## **95. Pachyammos 2**

### **95.1. General Information**

- *Name:* Pachyammos 2
- *ID:* CY0006010000000124

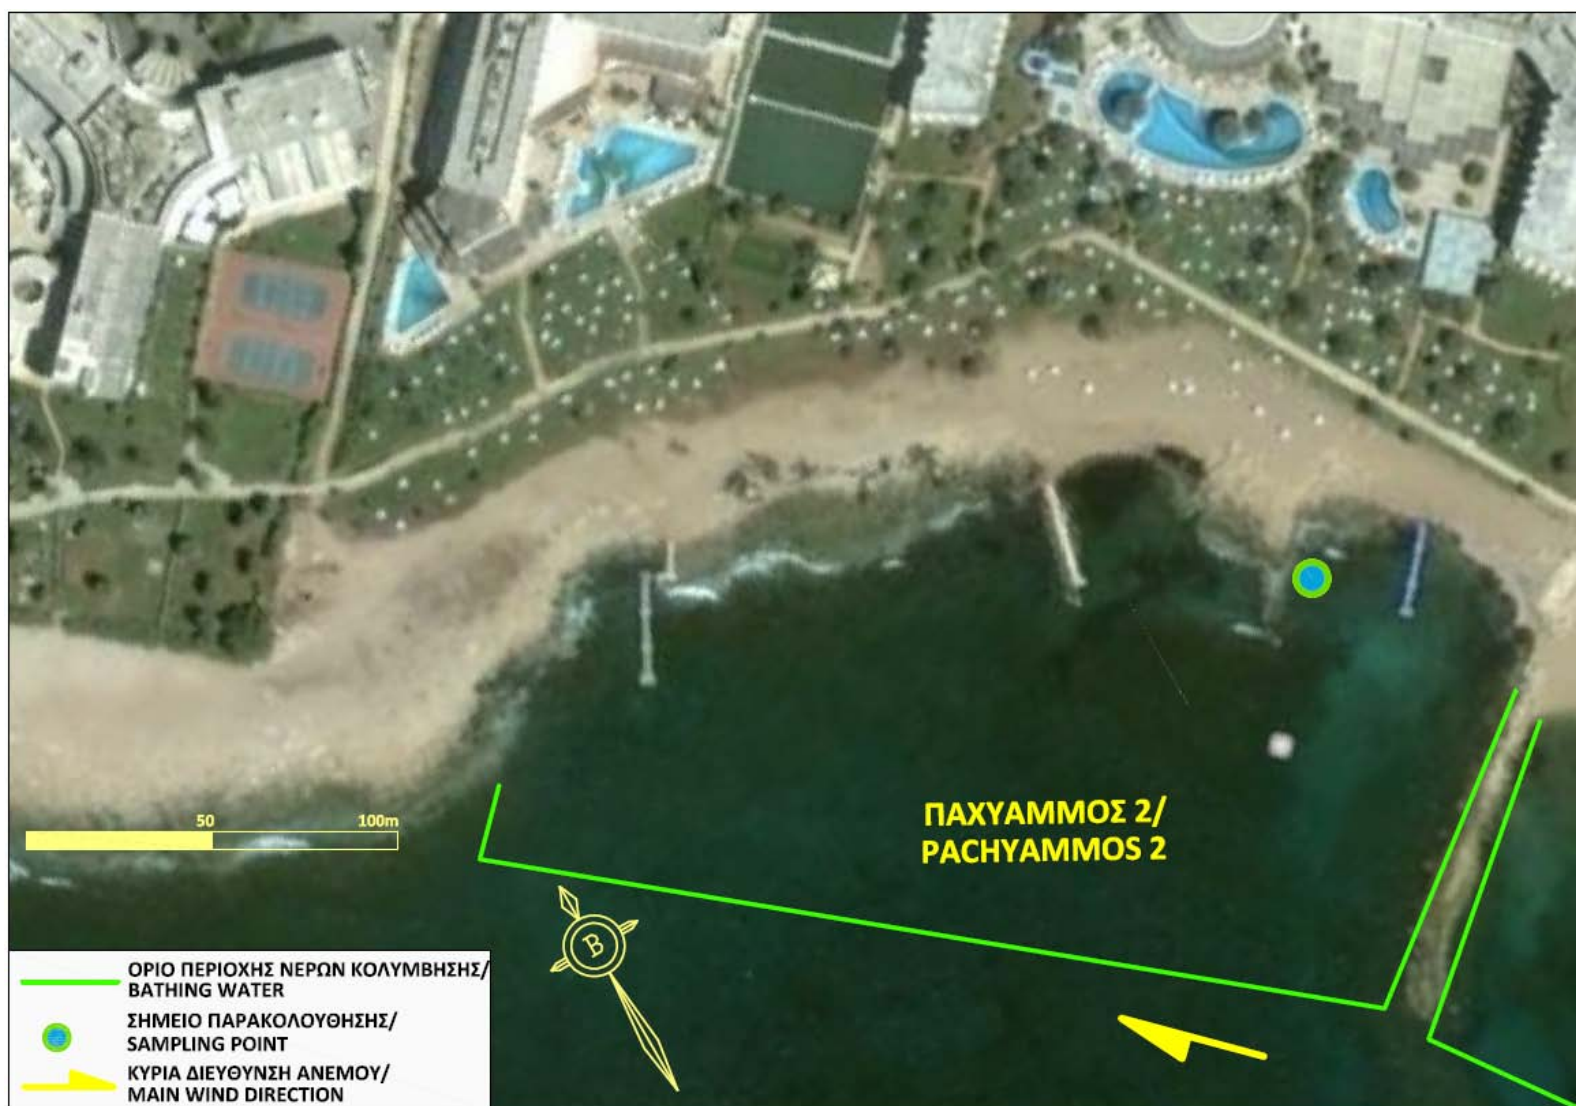
- *Location of the Bathing Water into the Water Body:* (see Figure)
- *Description of the Beach:* The beach is mainly rocky while to the south there are parts with sand. The substrate is hard sandstone. The beach is located in front of a hotel unit, while it extends from the southeast artificial bracket to the natural small cape northwest. At about 10m from the coastline the sand of the area is added or/and enforced in order to create the conditions for beach facilities. North of the beach, in front of the hotel unit there are ornamental plants.
