# ***DAMS OF CYPRUS***

***Water Development Department***

***NICOSIA - CYPRUS  
1974***

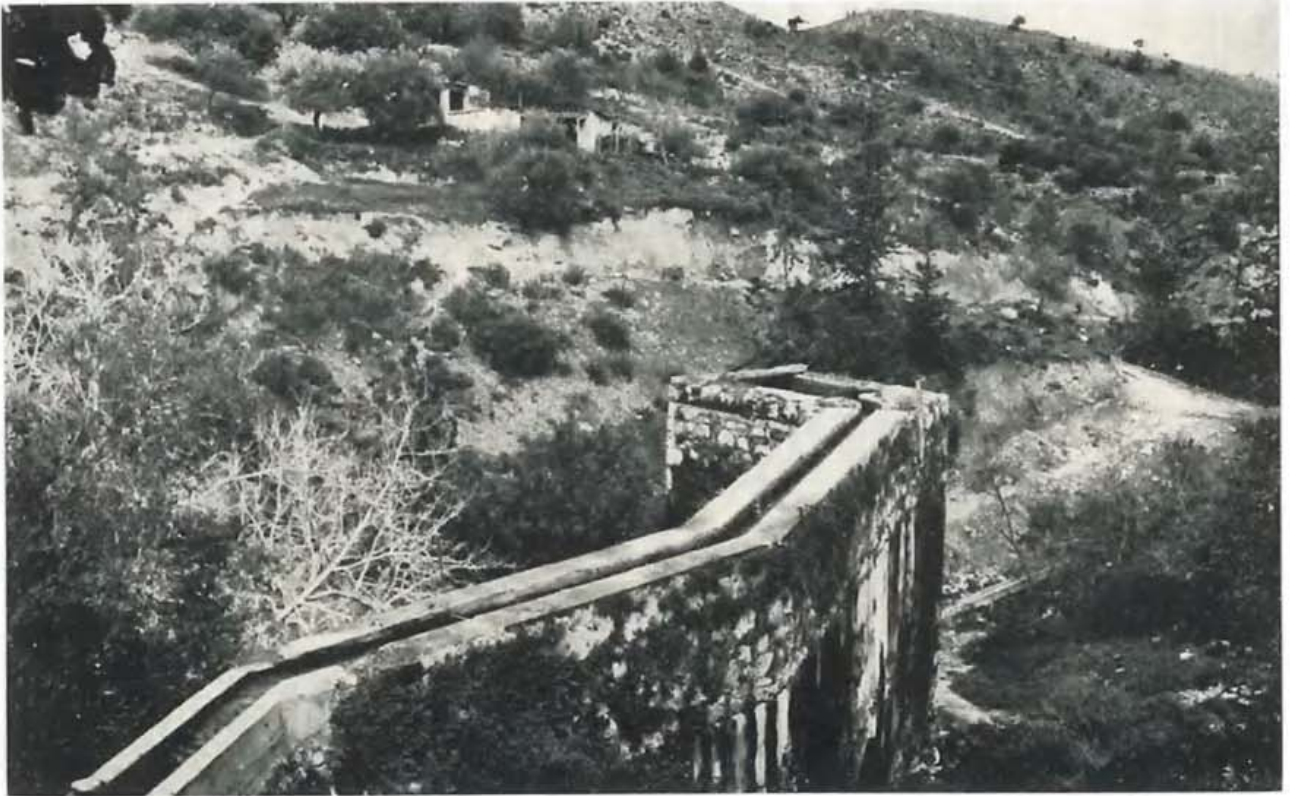
*Flour Mill using hydropower for the operation of grinding wheel.*

been for many centuries developed in Cyprus by conveying water from rivers over a vertical shaft, the falling energy of which would move grinding wheels for crushing wheat into flour. This form of power has now been replaced by modern petrol or electrically driven machinery.

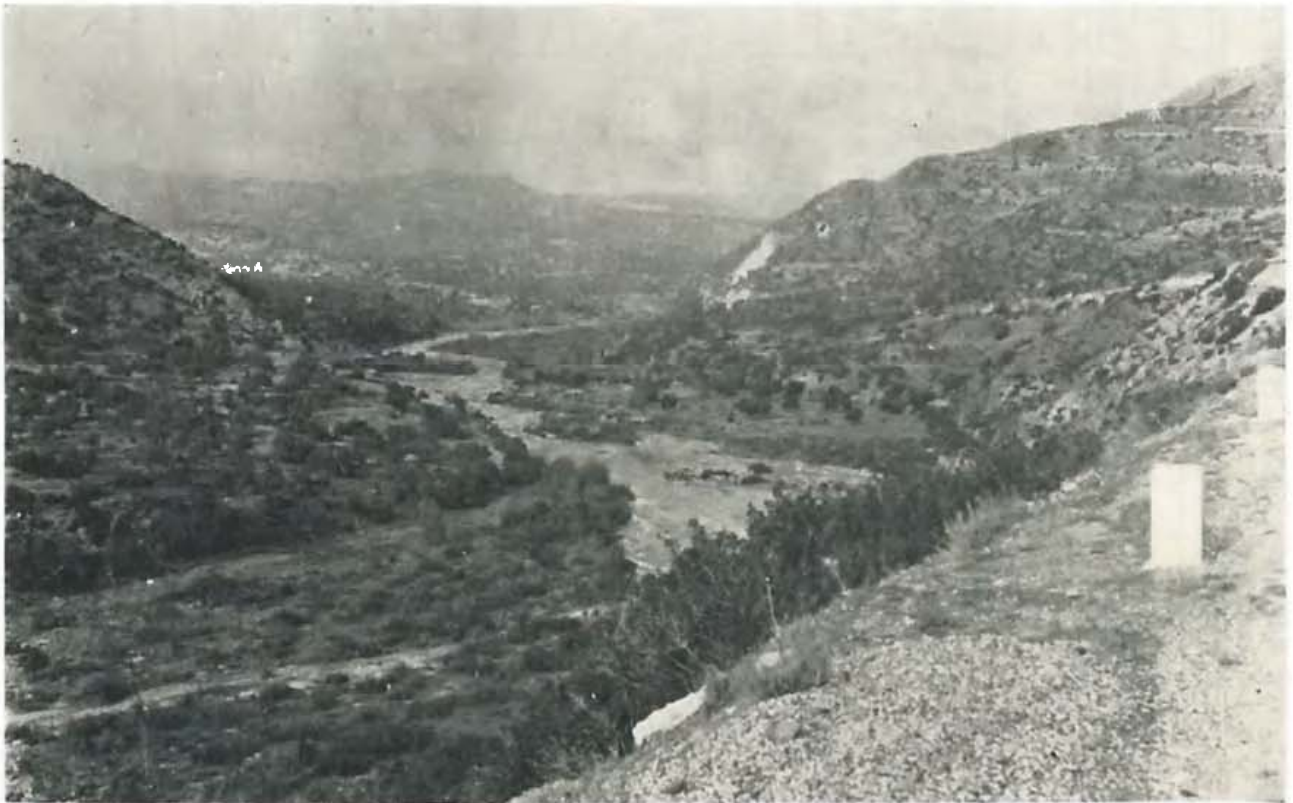
*The Kouris River showing the proposed dams site and reservoir of up to 100 million m<sup>3</sup> capacity*

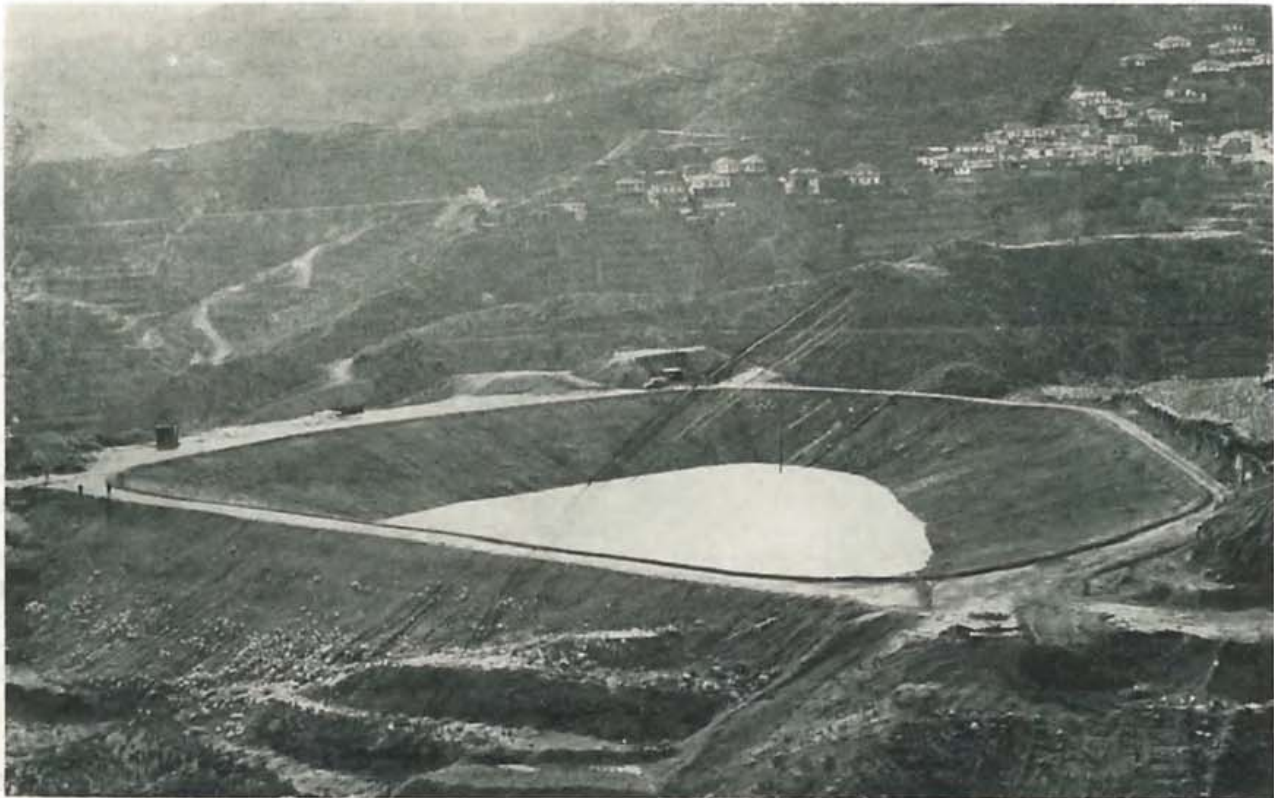
*Kyperounda Reservoir 1400 m asl. Excavated and earth fill. Polythene sheet cover 0.25 mm thick. Capacity 5,000  $m^3$ .*

Also a programme has been recently initiated for the construction of earth reservoirs of limited capacity in hilly areas, to enable the irrigation of small areas of permanent crops. Such earth reservoirs have been recently built and covered with Polythene sheeting 0.25 mm thick, at Margo near Nicosia of 60,000  $m^3$  capacity, and at Kyperounda at an altitude of 1,400 m asl of 5 000  $m^3$  capacity.

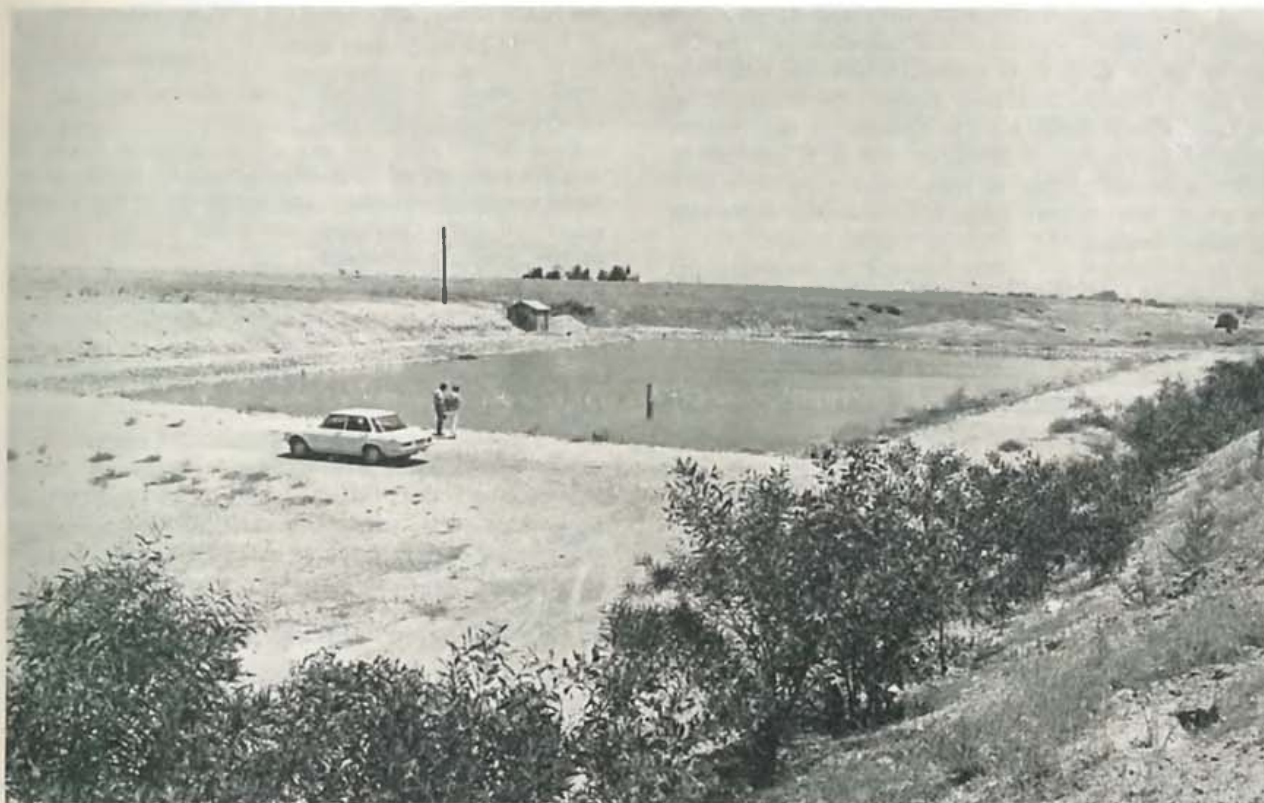
*Margo Reservoir: Excavated and earth fill. Polythene sheet cover 0.25 mm thick. Capacity 60,000 m<sup>3</sup>.*

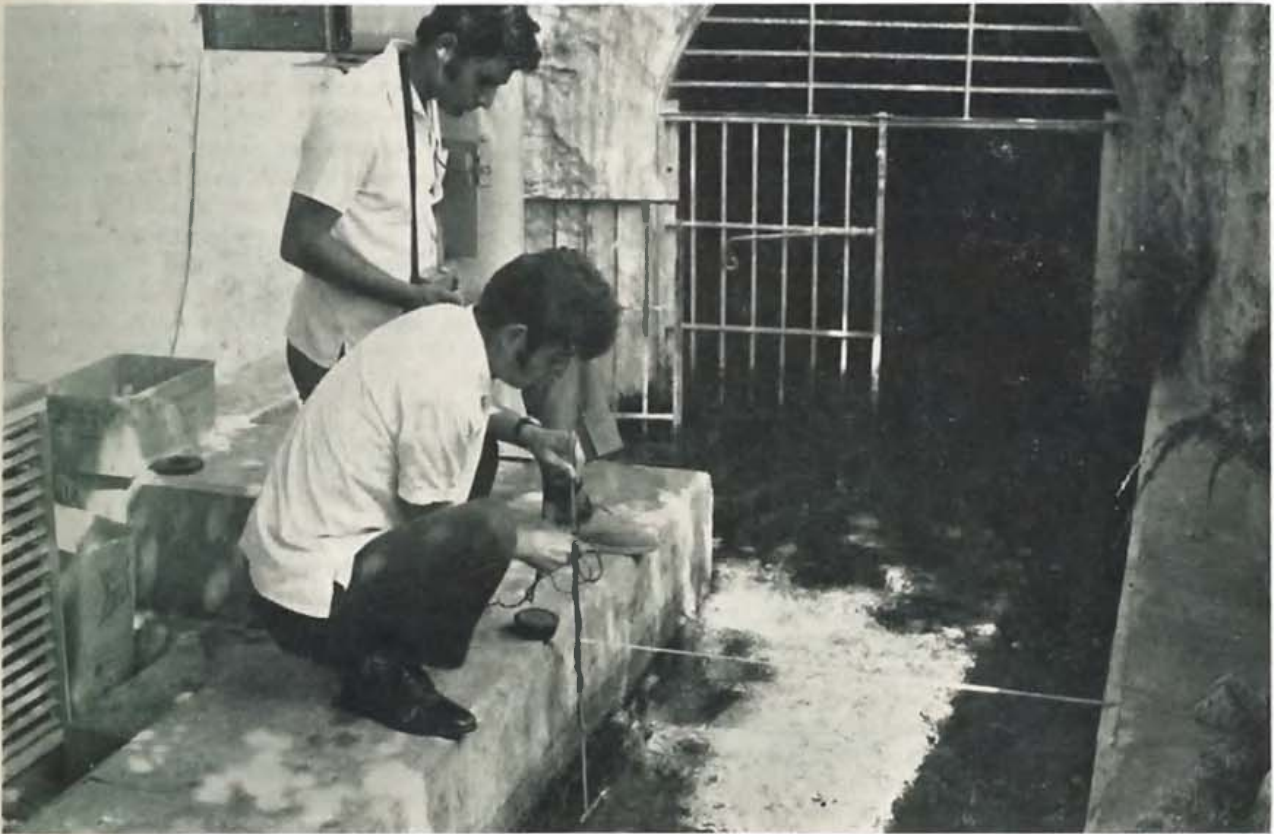
*Current meter measurements of flow at Kythrea Kephalovrysos spring.*

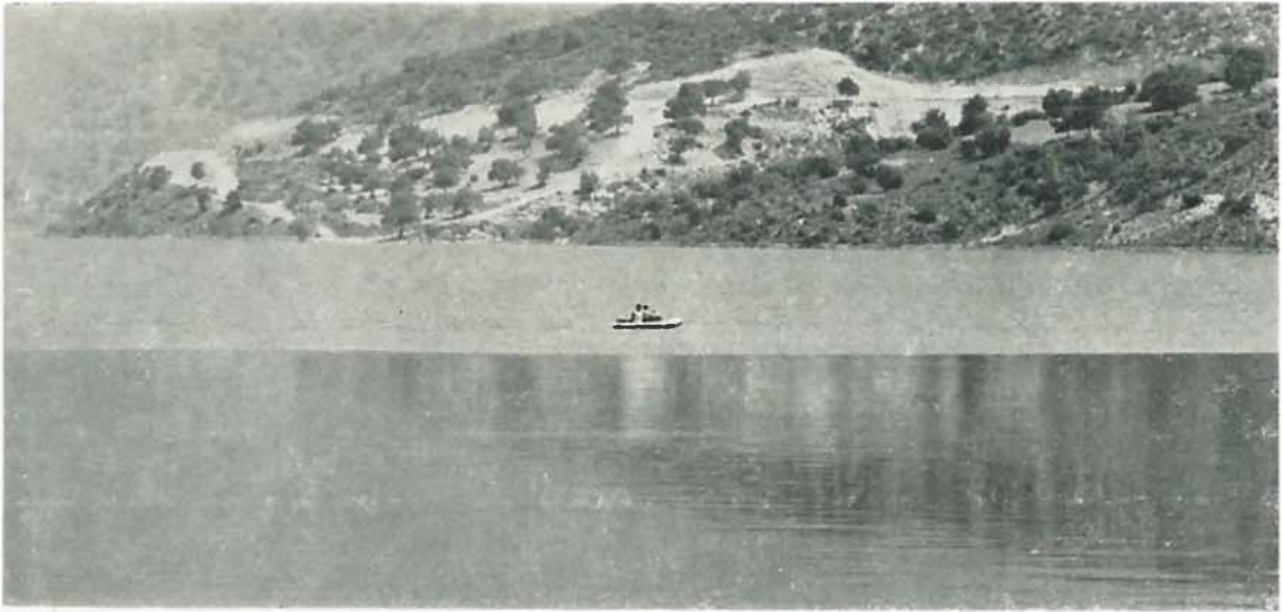
*Application by boat of Cetyl Alcohol in the Yermasoyia Dam Reservoir for the reduction of evaporation rate. In the foreground the treated part can be seen with the film cover showing distinctly.*

In the case of Yermasoyia dam it has been estimated that the water saved from evaporation during the period of hexadecanol application was 32% whilst the cost of the water saved was 5 mils/m<sup>3</sup>.

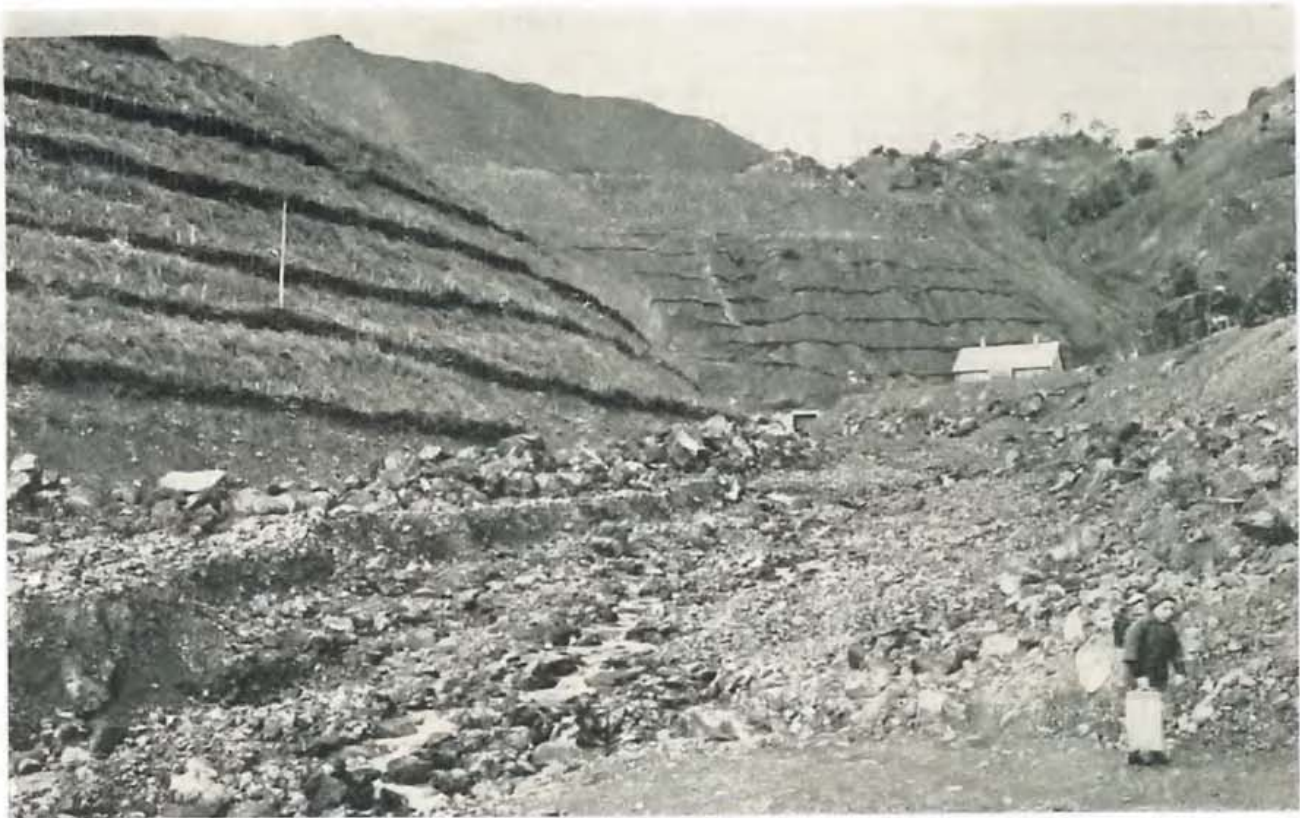
*Old waste dumps at Amiandos Mines showing timber staking and tree planting for the prevention of erosion*

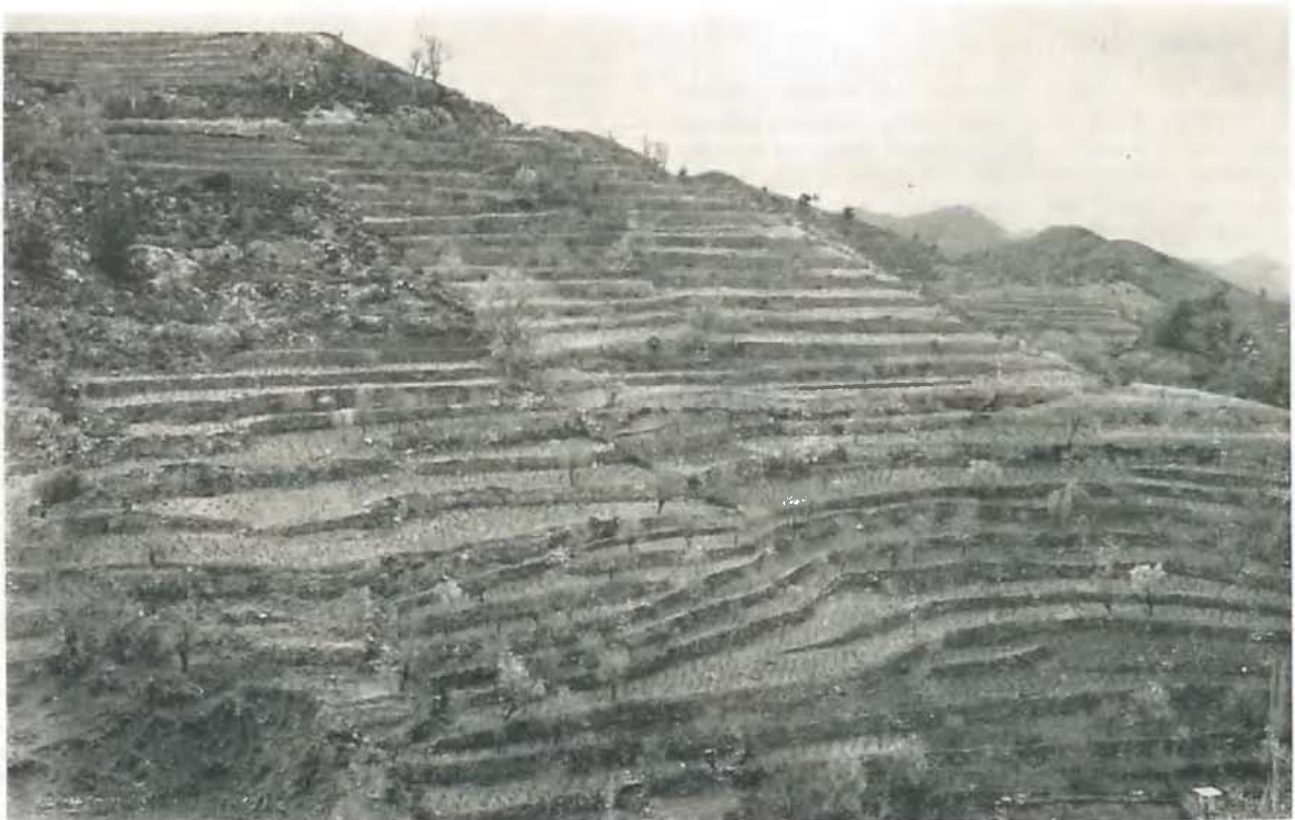
*Mountain terracing for the prevention of erosion and planting of almond trees and vines.*

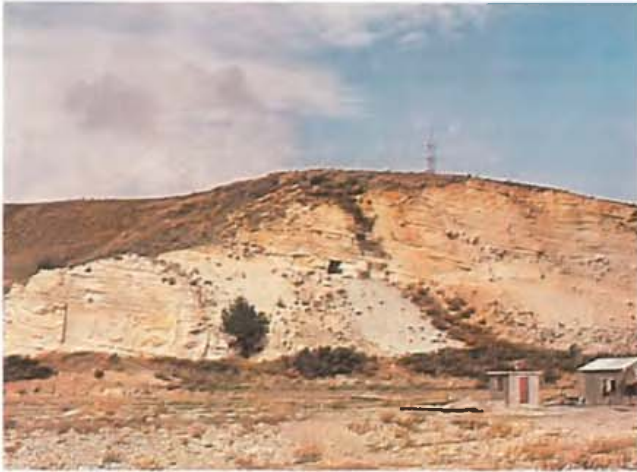
**Pakna Formation (white brownish chawks) overlying Lapithos Chalks (lighter colour, left centre). Proposed dams site at Asprokremmos, Xeropotamos River, Paphos District.**

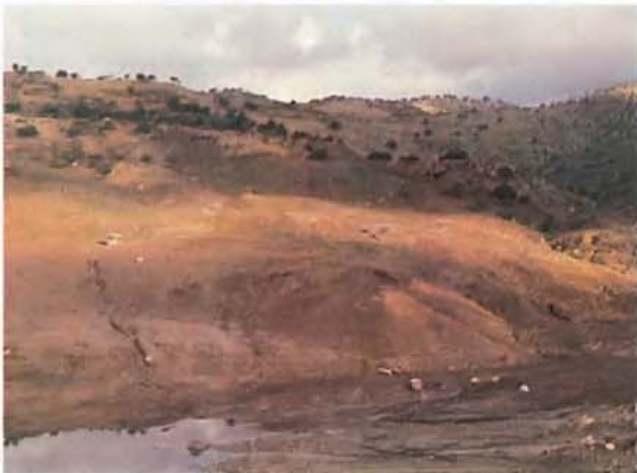
**Mamonía Complex, igneous and sedimentary rocks overlain at top by Lapithos Chalks. Lower part of photo shows reworked sedimentary rocks of the Complex with obvious landslides. Mavrokolymbos reservoir area, Paphos District.**

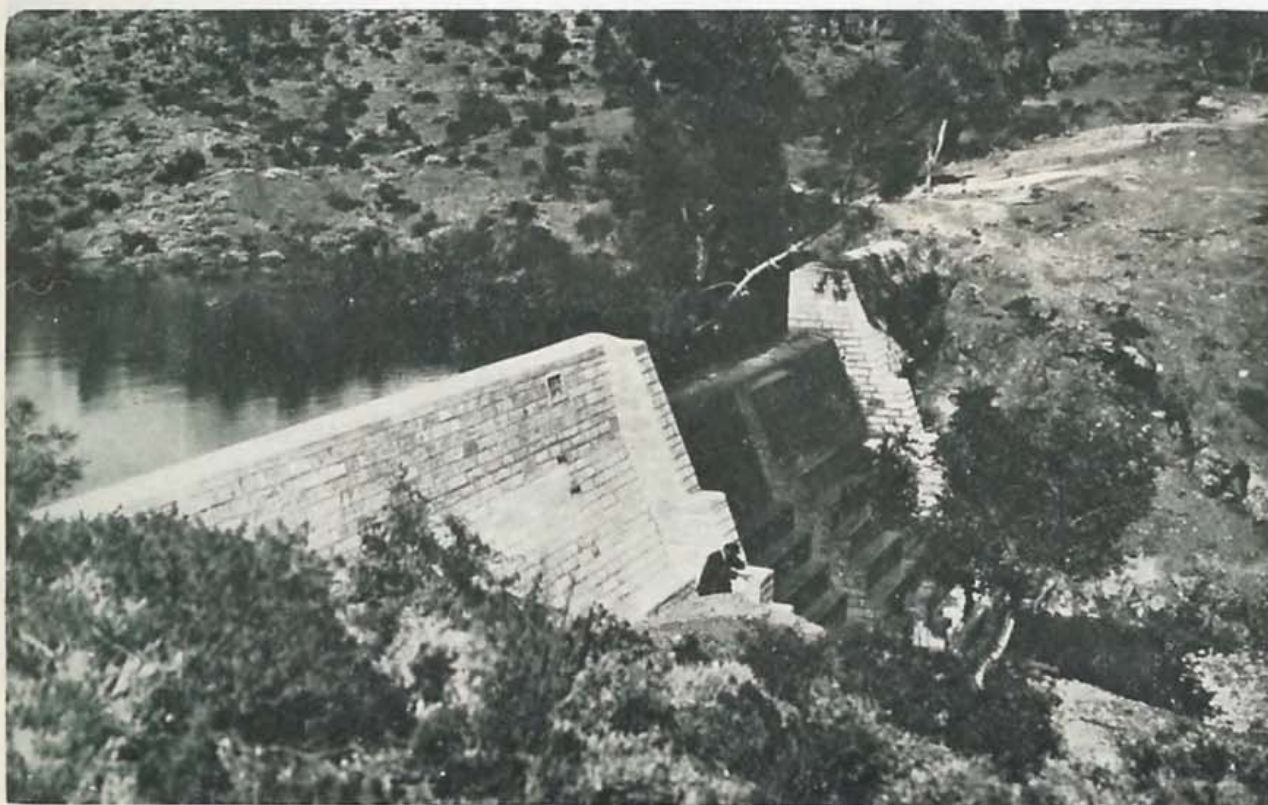
*The Kophinou masonry dam.*

diverting water have been built starting with the decade of 1940. The Kophinou, Lymbia, Akrounda and Geuneyli small dams are examples shown in the accompanying photographs. The nine largest masonry dams which are of some importance will be described in this chapter. The eight of them are gravity dams, and one is a buttress dam. The properties of the stone used and the main design characteristics for each dam

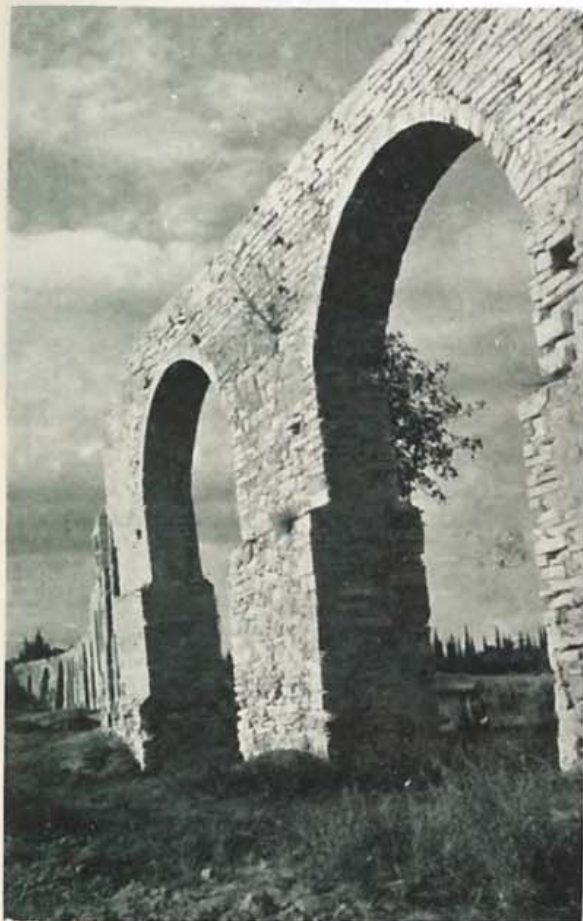
*The Old Bekir Pasha aqueduct for the Domestic Water Supply of Larnaca.*

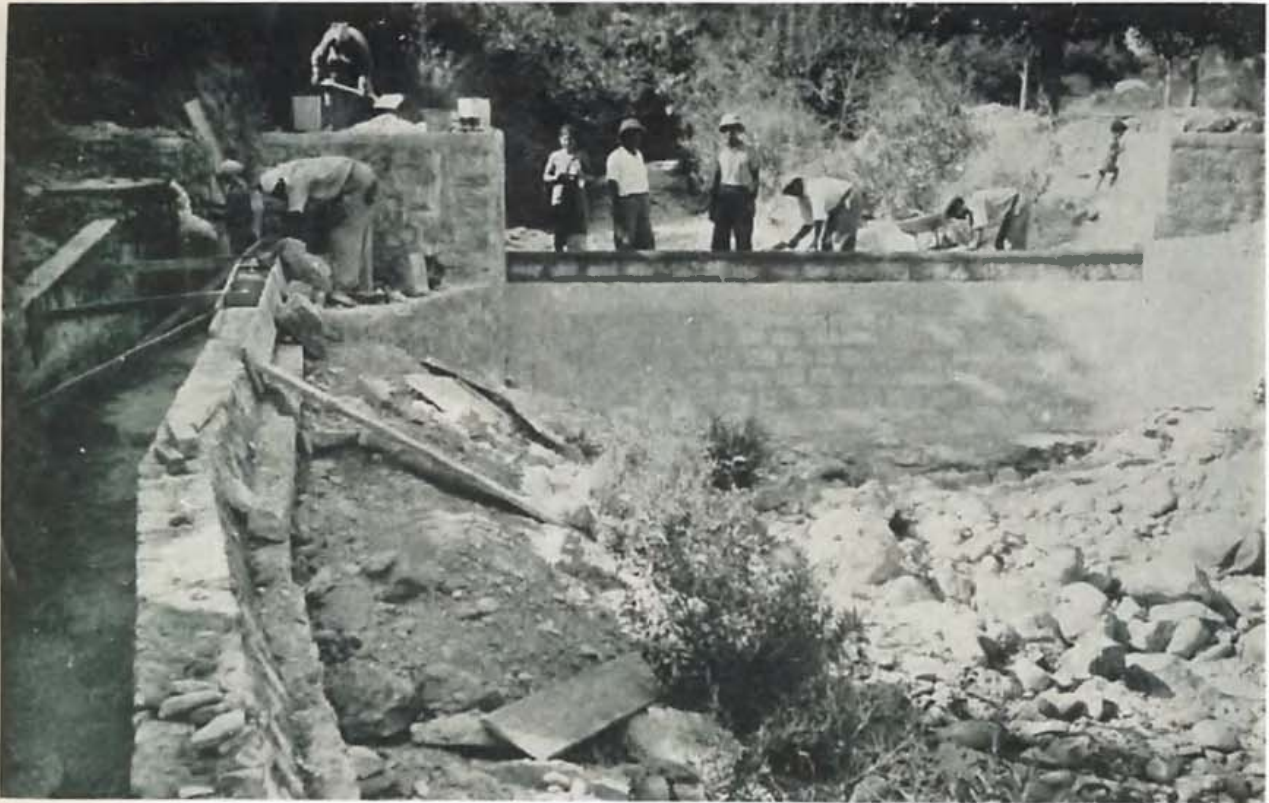
*Masonry river diversion weir and intake channel.*

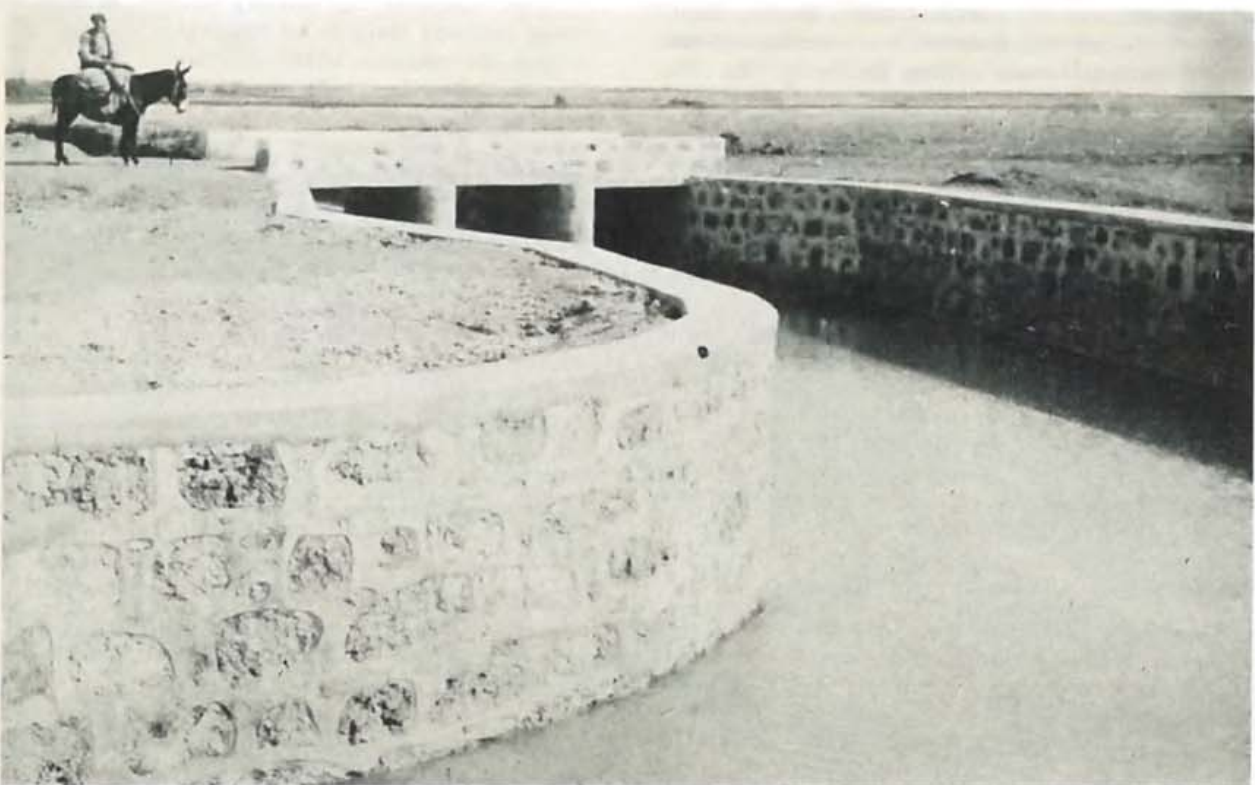
*Masonry conveyor channel and bridge.*

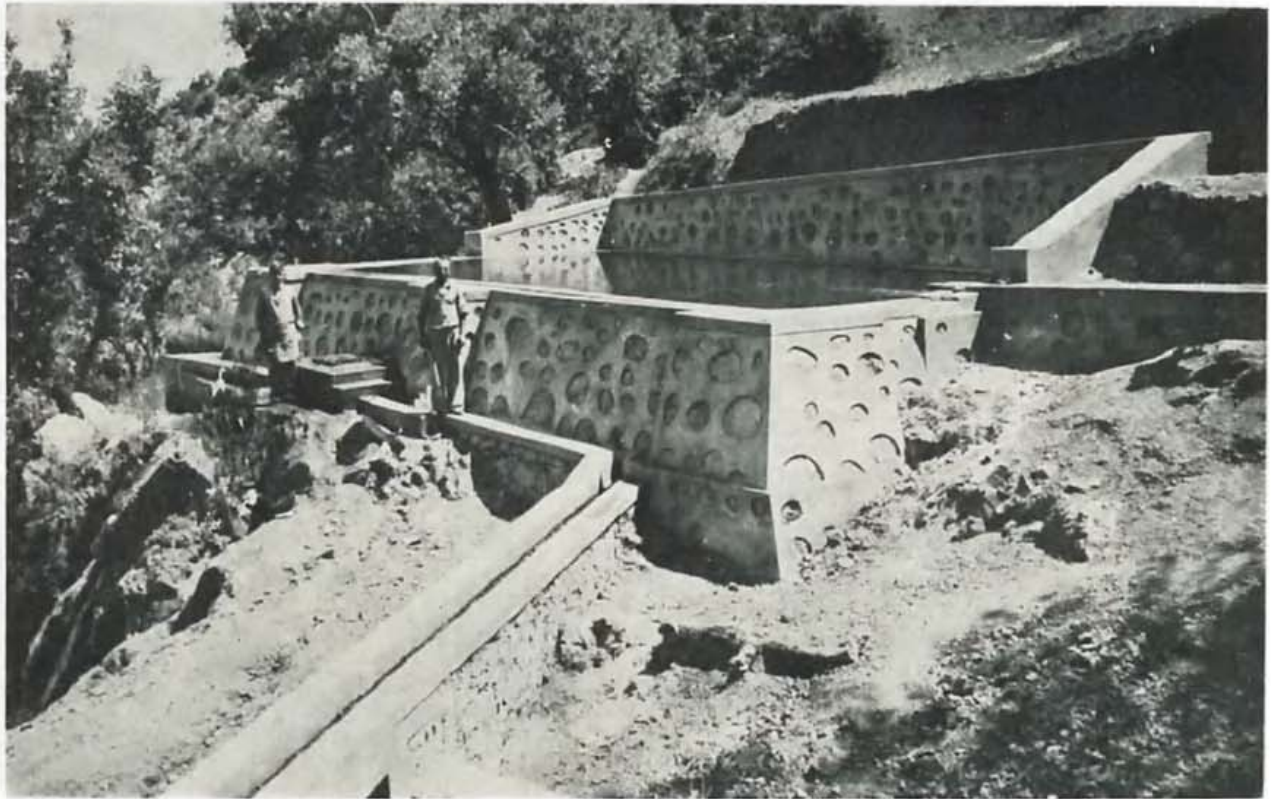
*Masonry reservoir and intake channel*

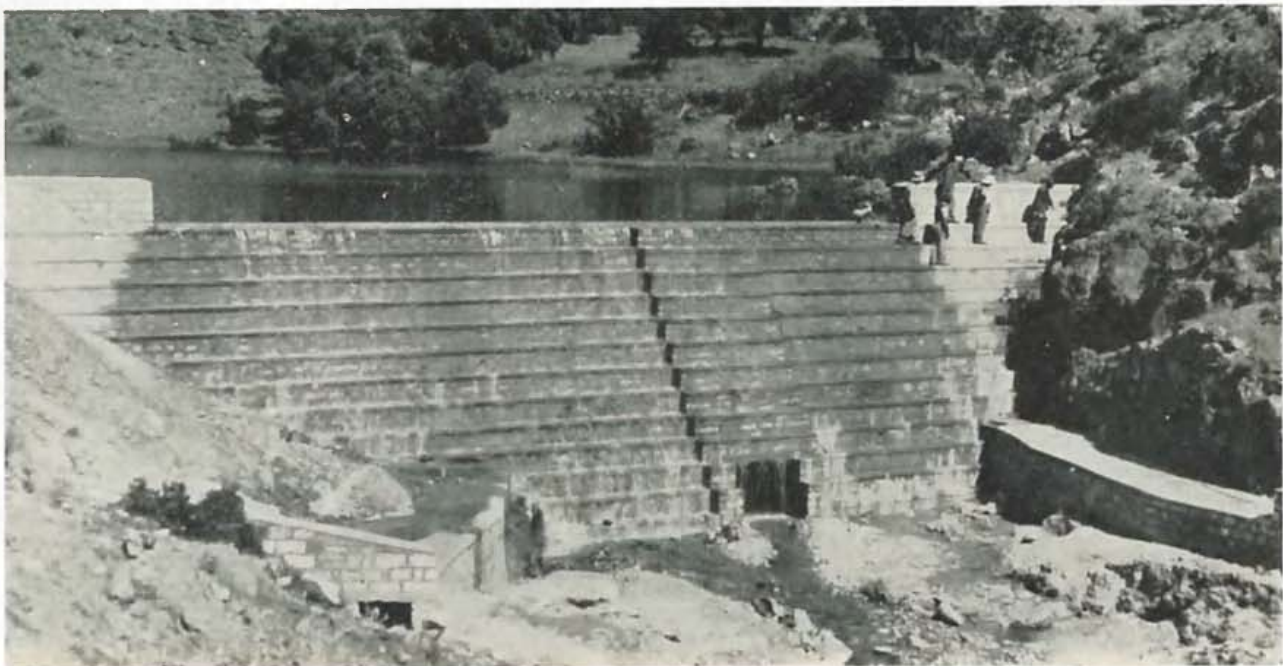
*The Akrounda masonry dam.*

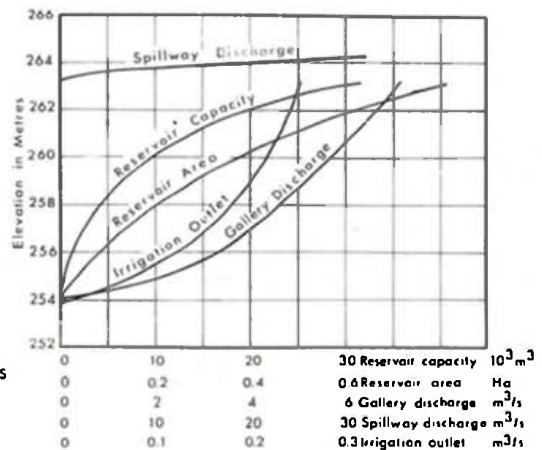
CAPACITY-AREA-DISCHARGE CURVES

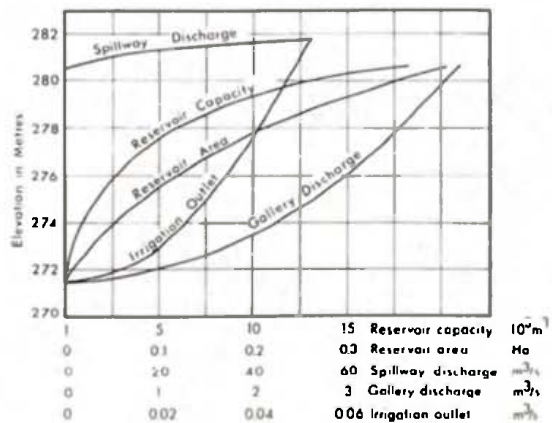
CAPACITY-AREA-DISCHARGE CURVES

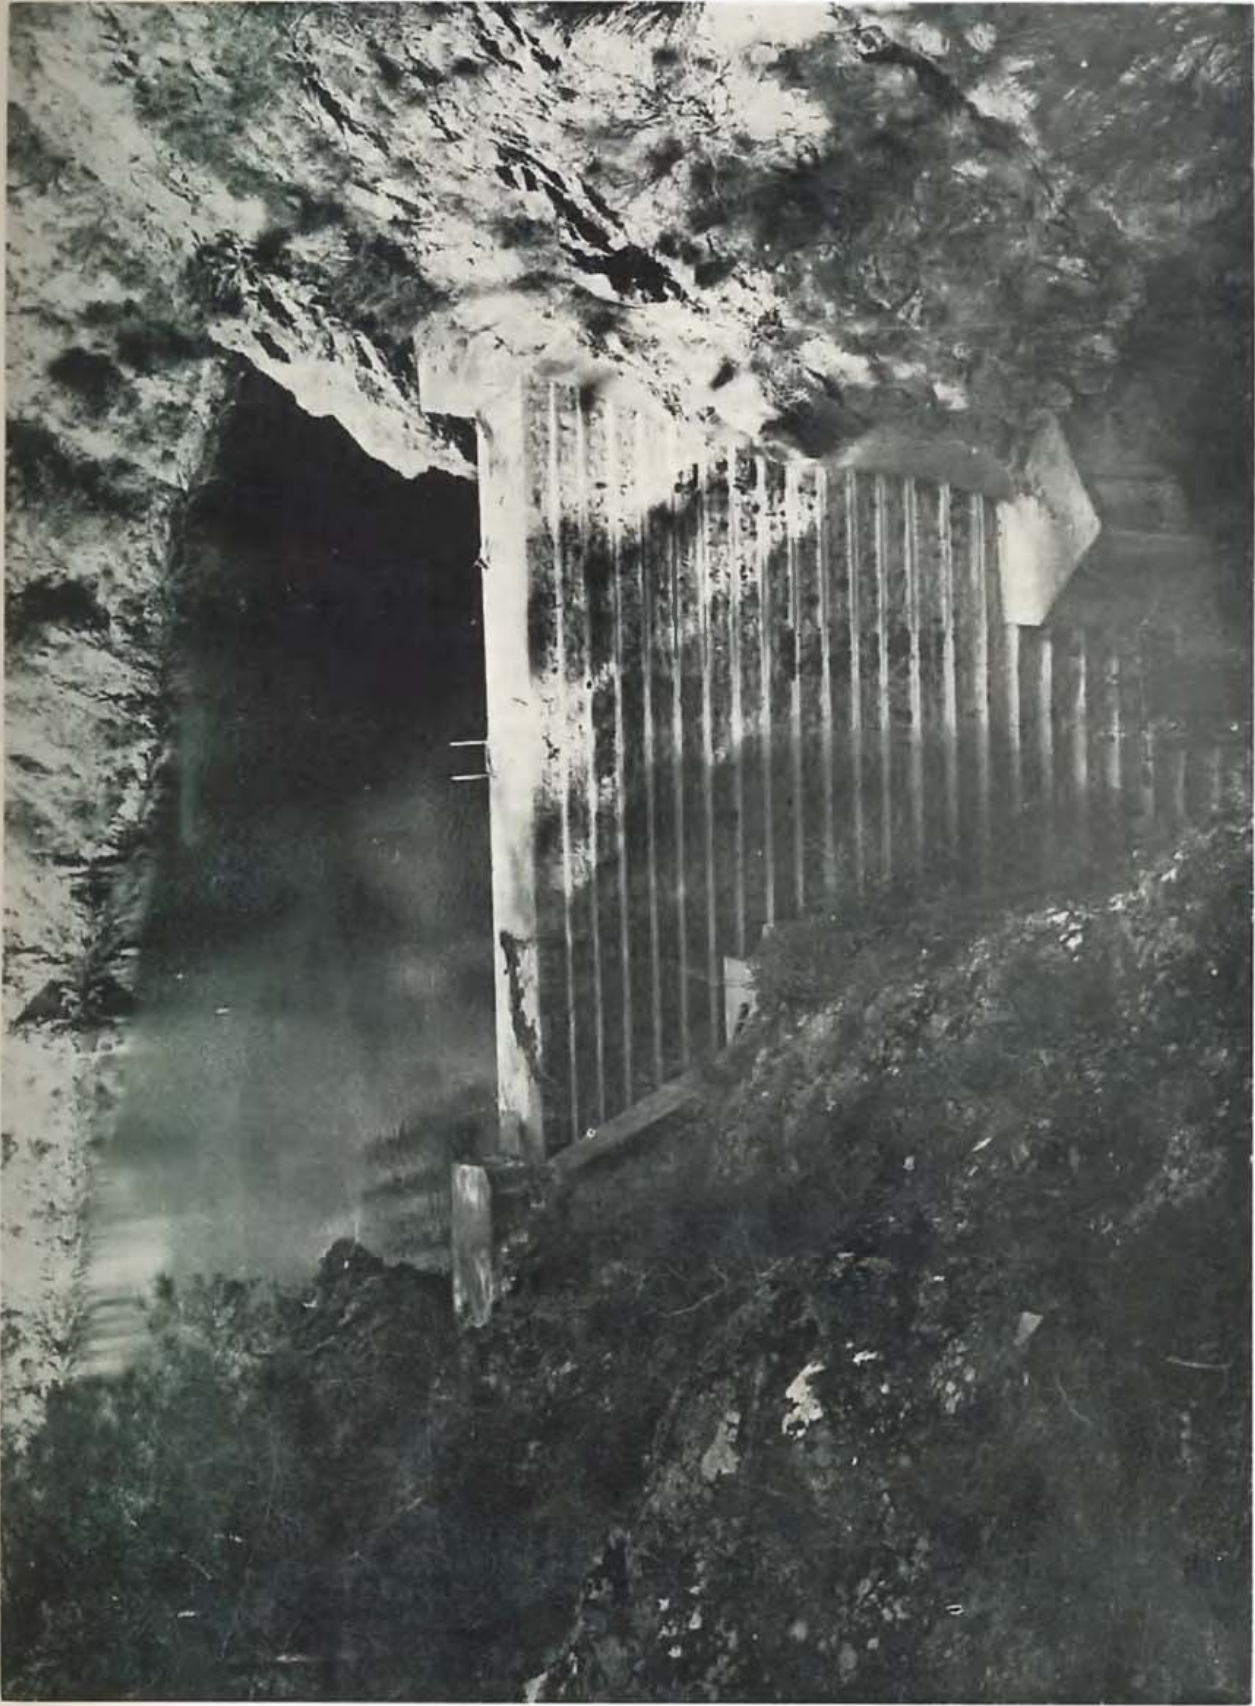
*The Galini dam.*

The total volume of excavations was 220 m<sup>3</sup>, and that of the masonry fill 700 m<sup>3</sup>. The foundations were filled in lime-cement-concrete 1:2:9 and the masonry fill was placed in lime-mortar 1.2:9. Diabase rocks used for the masonry work were obtained from the site and the concrete aggregate from the nearby sea shore. The upstream face was plastered in three coats of cement mortar to prevent seepage through the structure, whilst the downstream face and wingwall masonry were pointed in cement mortar. The total cost of the dam was £4,000.

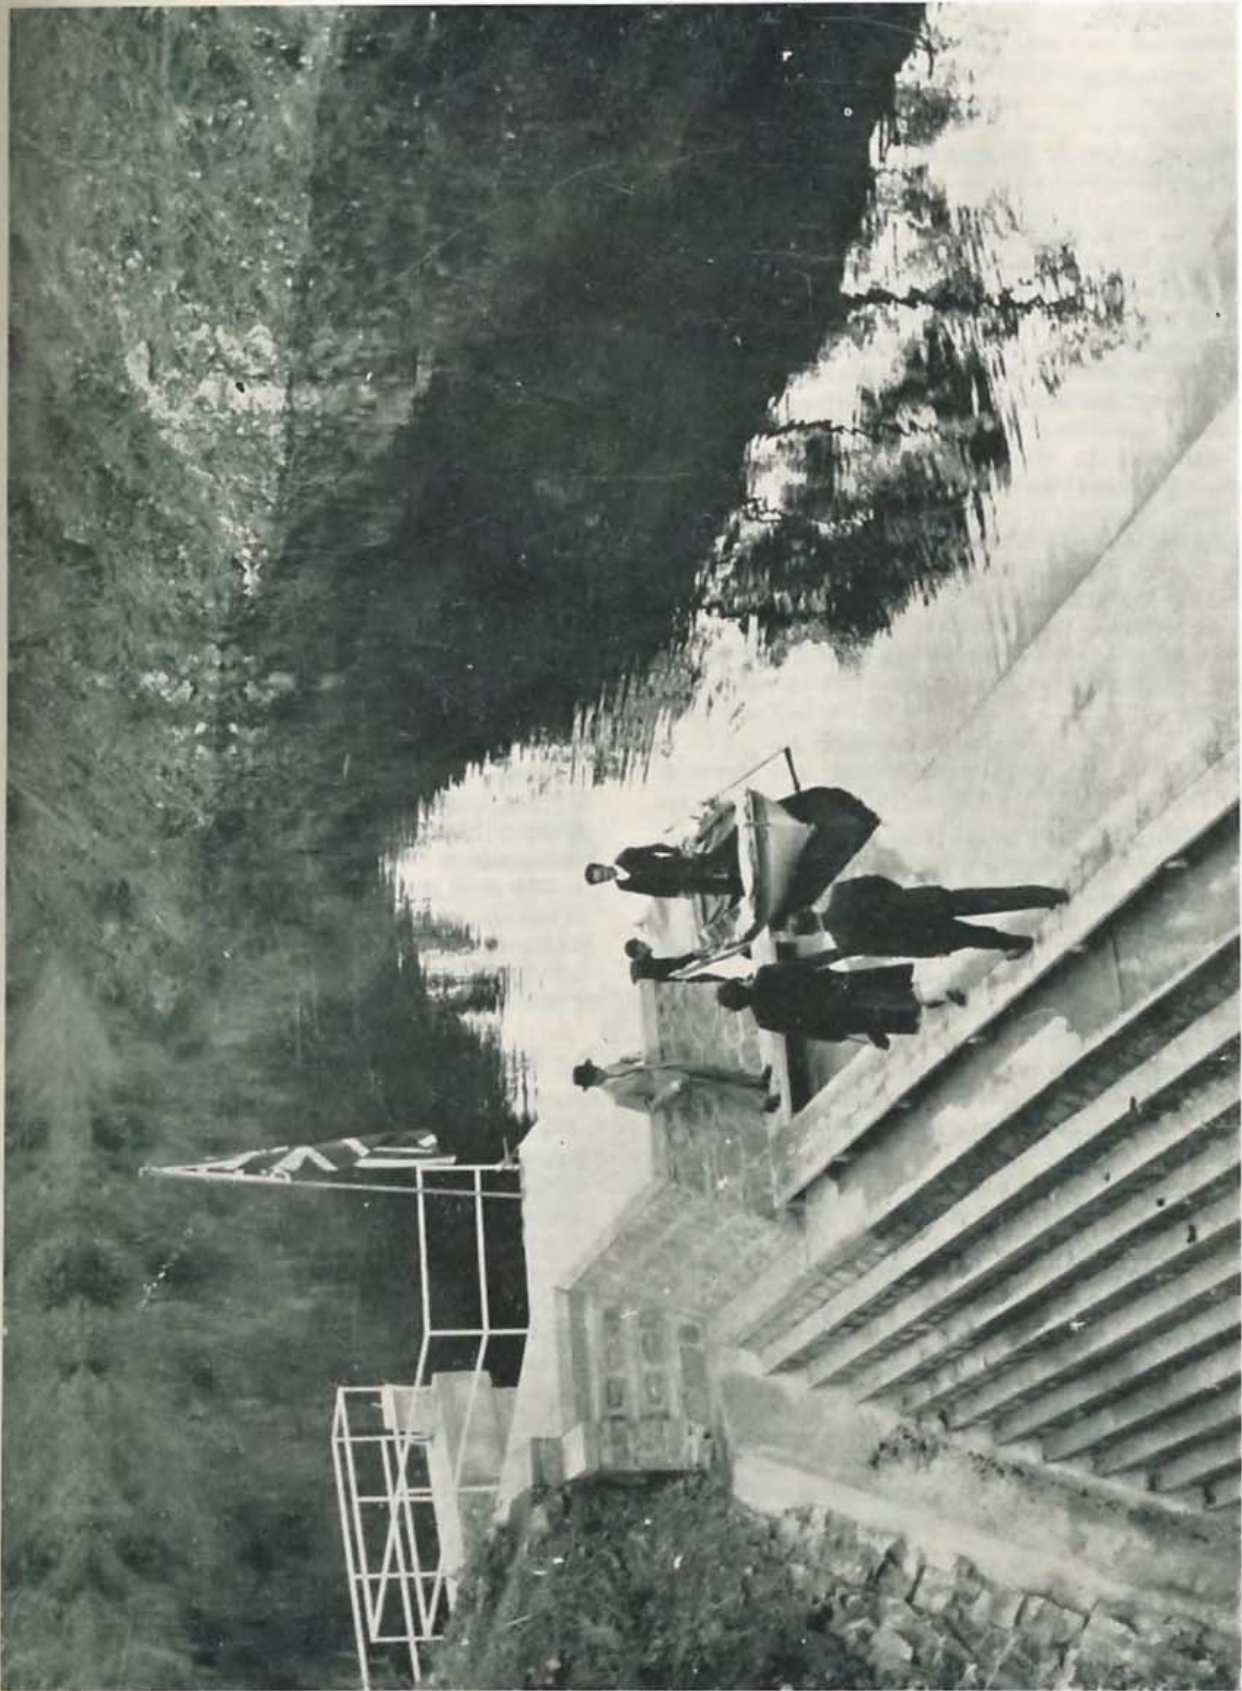
*The Kafizes dam.*

The foundations are in cement concrete 1:3:6. The lower 4 m part of the dambody is of masonry set

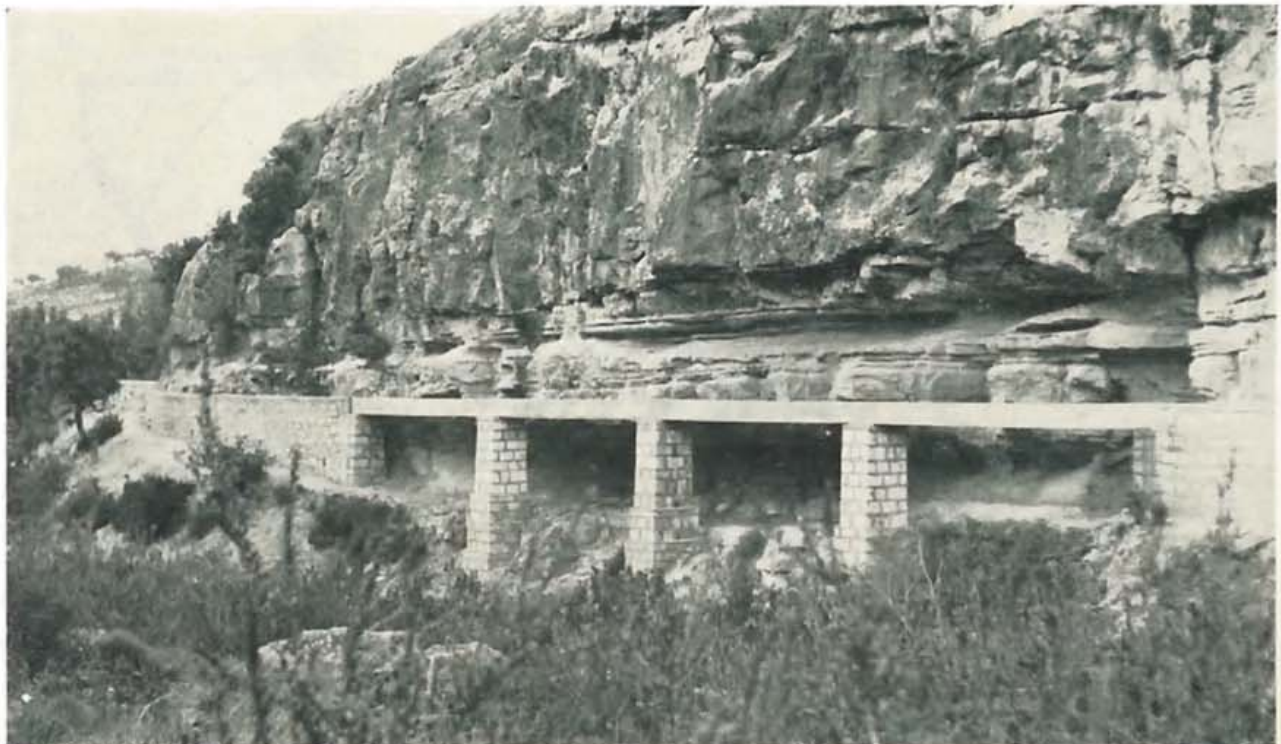
*The Kandou masonry - concrete irrigation aqueduct.*

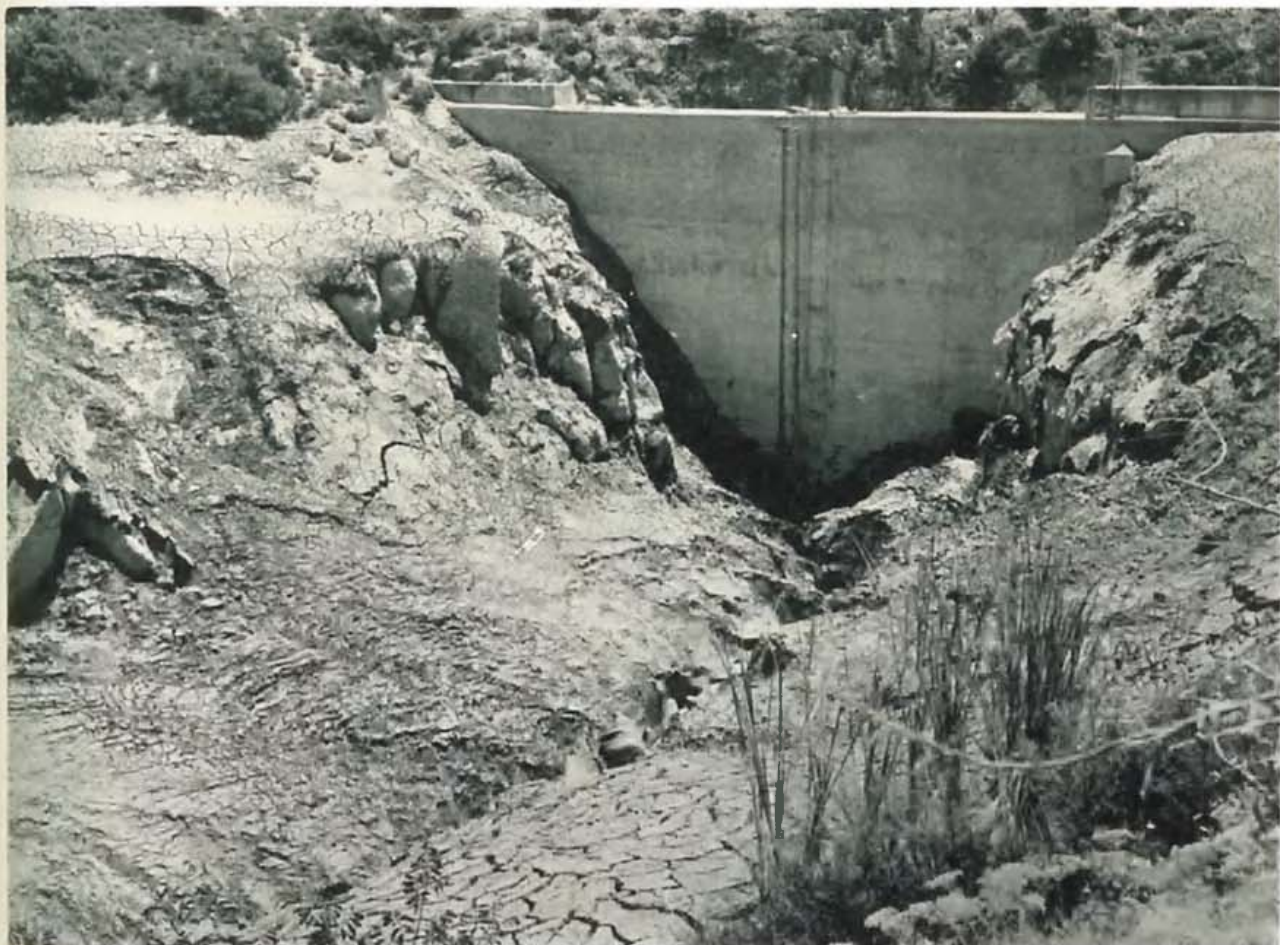
*Trimiklini dam in May 1969 showing silt deposited in the reservoir from erosion of the Asbestos Mines dumps upstream. The depth of the silt at the lowest point is 8 m.*

The main problem regarding this dam is that of the heavy silt sediment which has its sources from the Asbestos Mines about 9 km upstream. The Mine has been in operation for over 50 years now and has been dumping its wastes along the river valleys thus becoming a potential source for silt erosion and transportation in the river downstream. The Mines operations result in some 2 million tons of waste every year which has to be dumped somewhere. It was first found by the Mines that the easiest dumping place was the river valley the water of which would gradually transport these materials downstream. However, in time, the interest for irrigation increased and downstream irrigators got concerned about the amount of silt, the fine particles of which resulted in an impermeable thin layer laid over the land when this water was used for irrigation. This silt clogs the pores of the soil and therefore the percolation of water to the root zone is prevented. With the erection of this dam,

However, in spite of important improvement measures taken by the Mines, the worse situation developed in 1968—69. In October 1968 the pressure from the sediment caused a breakage to the operation mechanism of the gates. Immediately after, six attempts were made by skin divers who eventually managed to lift the gate by the use of a crane so that
