# ***DAMS OF CYPRUS***

***Water Development Department***

***NICOSIA - CYPRUS  
1974***

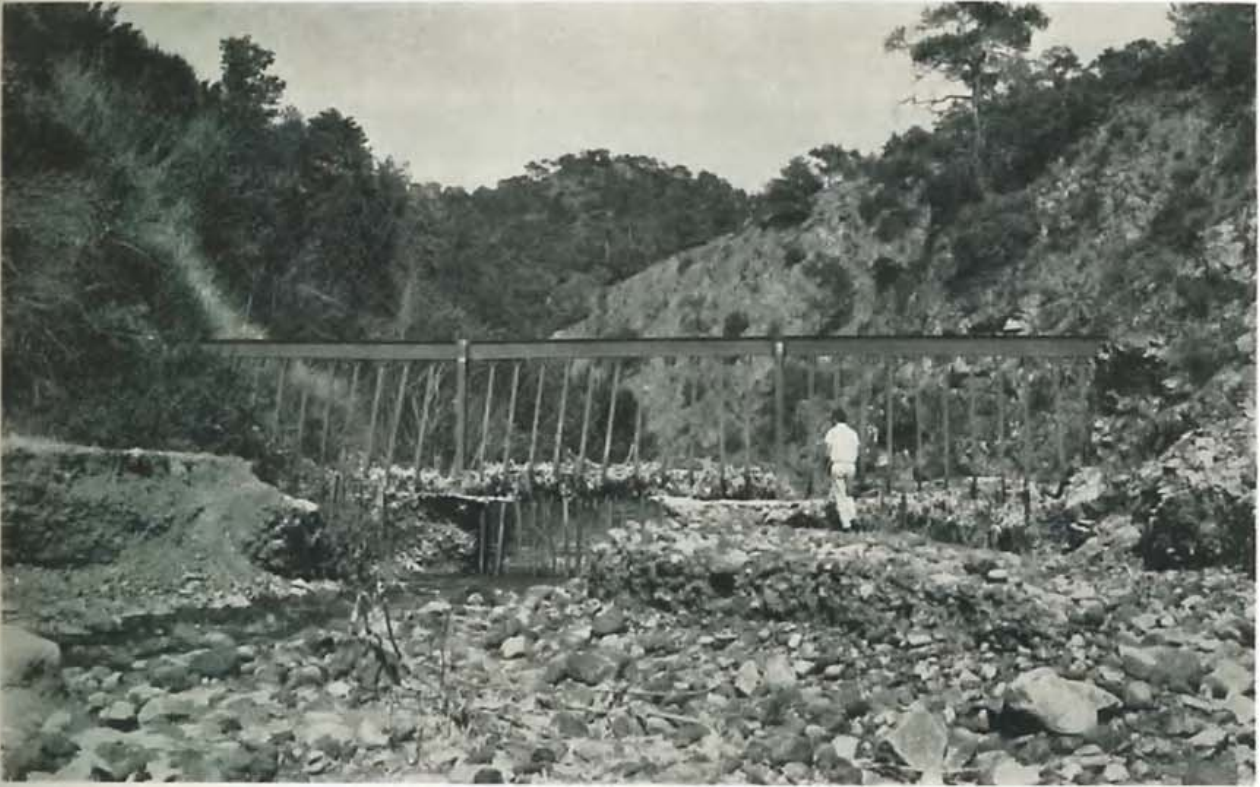
*Trimiklini dam. — Upstream silt trap.*

in the tunnel. This blasting was successful and the tunnel was cleared and emptied in 2.5 hours. Immediately all metal structures were removed from the riverbed to avoid blocking of the tunnel again. All this operation for clearing the dam lasted until the end of November 1969 and the total cost was £2,100. After these desilting works were completed, the Mines undertook to introduce a different type of desilting arrangement which consisted of a vertical outlet tube of 1 m dia connected to the tunnel at the small gate entrance and fitted with 12 trap gates. A hand operated winch was installed on the spillway crest to operate the penstock and trap gates. One iron penstock 1.37x1.2 m was installed on the big tunnel entrance held in position by the pressure of the water. Finally, upstream of the reservoir a protecting grill 16 m wide and 2.5 m high was installed consisting of 3 sections each having 11 pendulum type iron hooks (see photo). This grill serves the purpose of holding all tree trunks and drift wood back. In the case of the large rocks the pendulums help to retard their movement thus preventing the breakage of the grills.

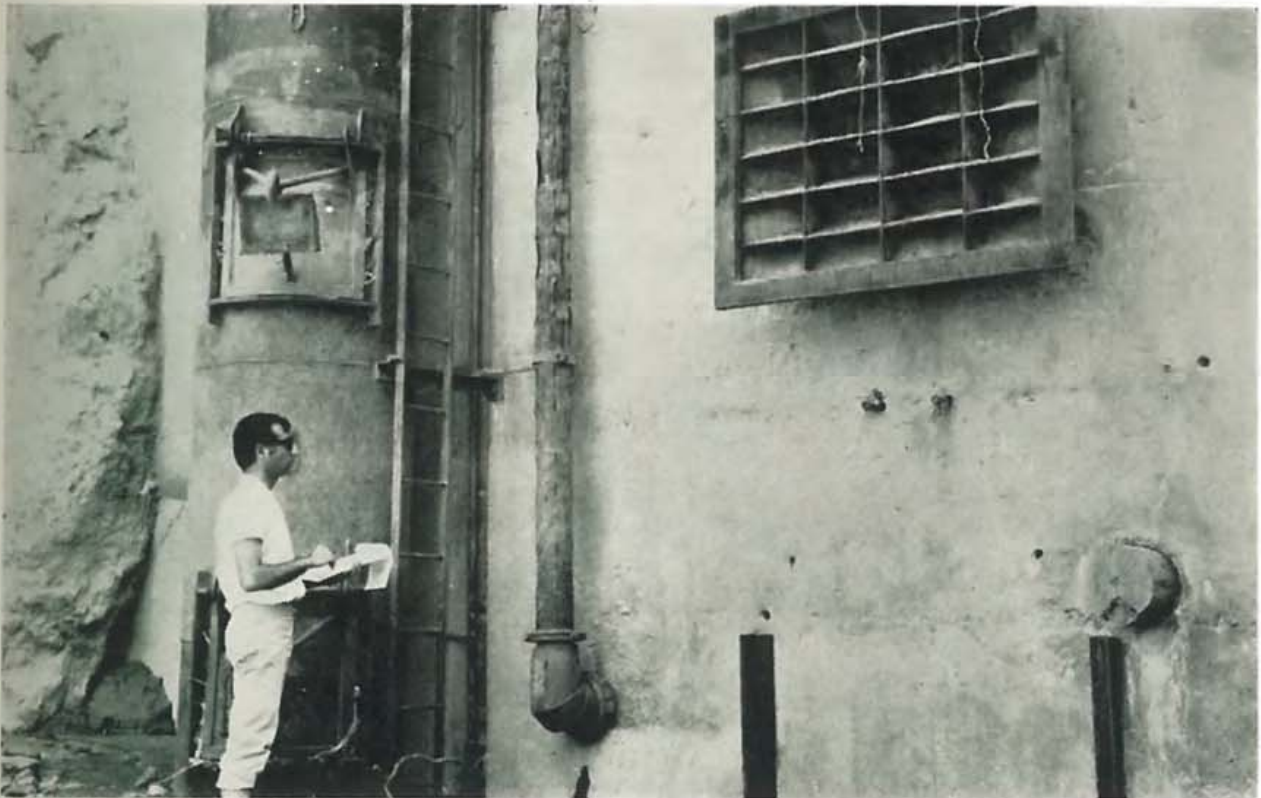
*Trimiklini dam. — Desilting pipe with trap gates.*

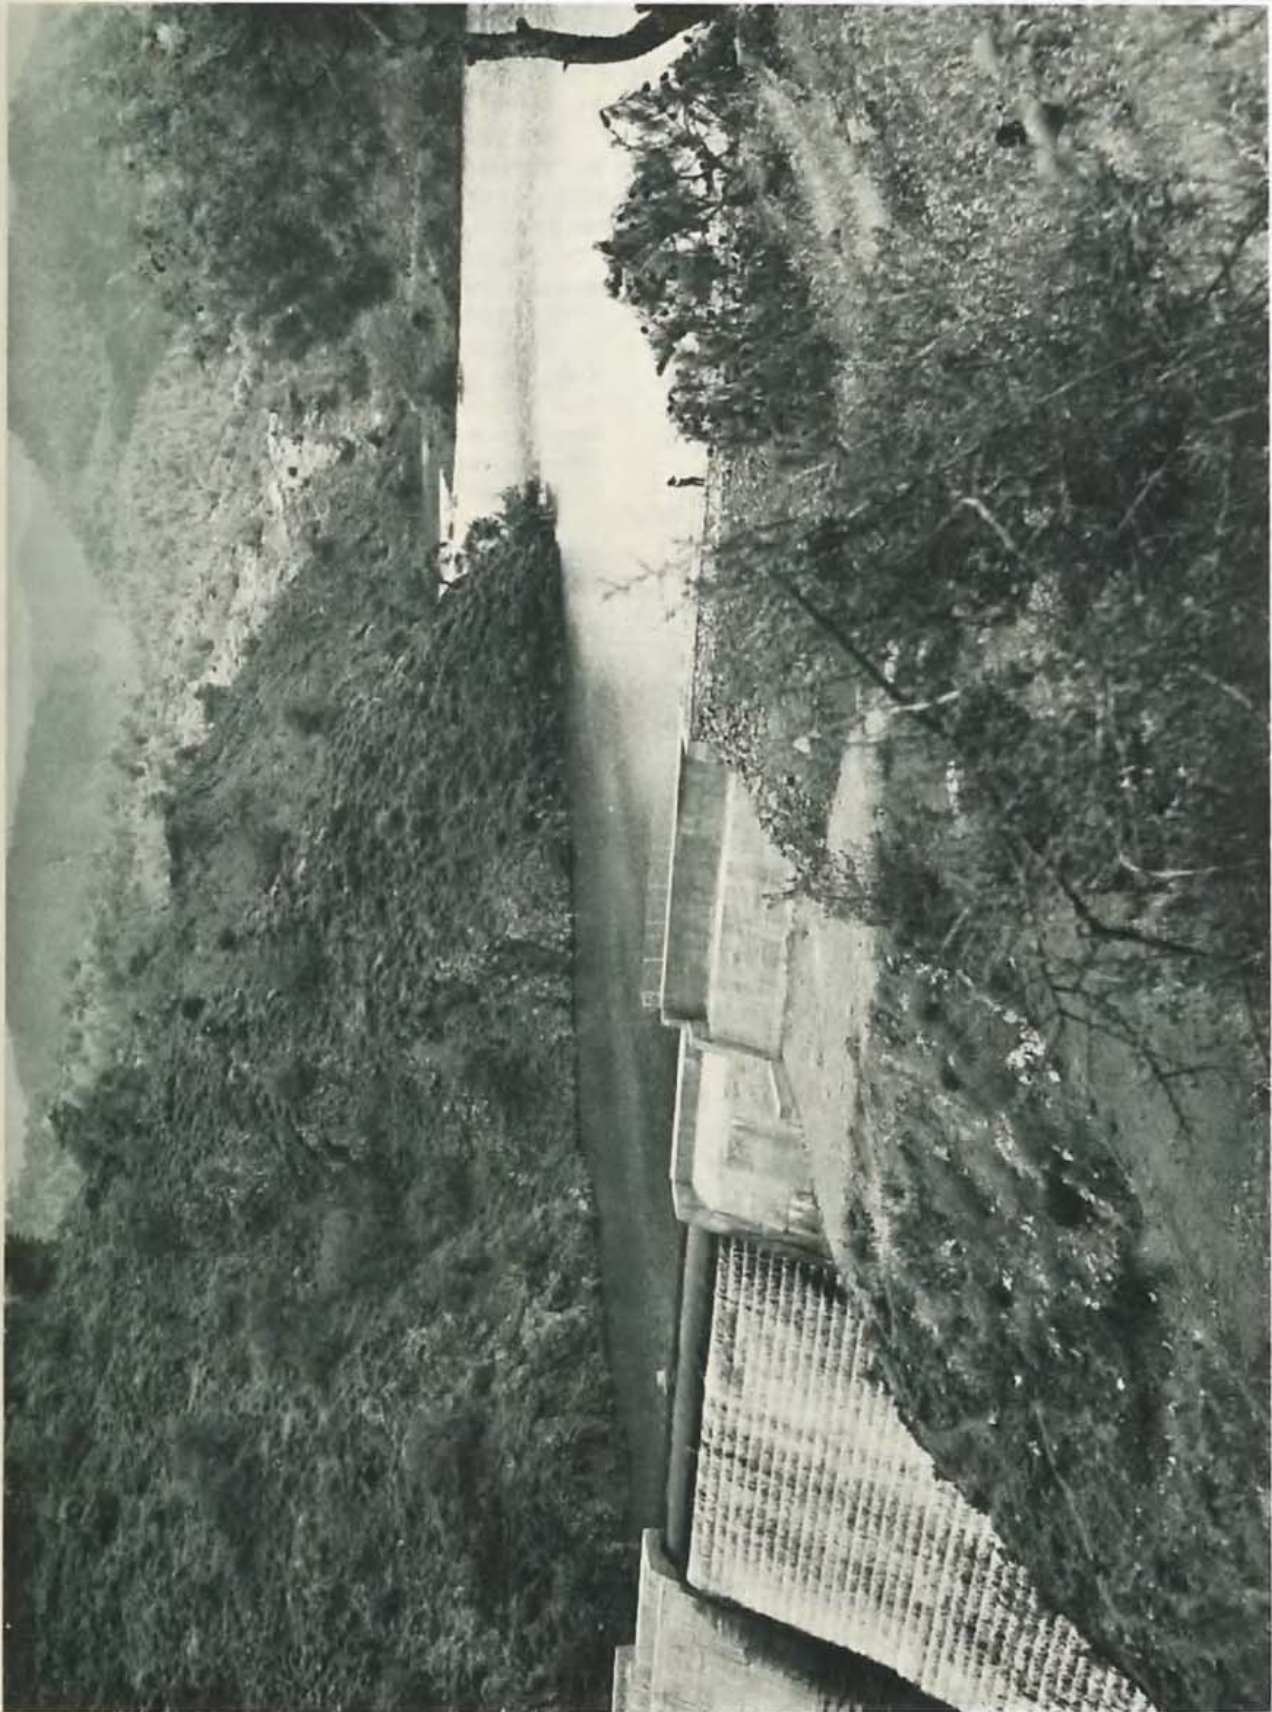
*The Lefka dam.*

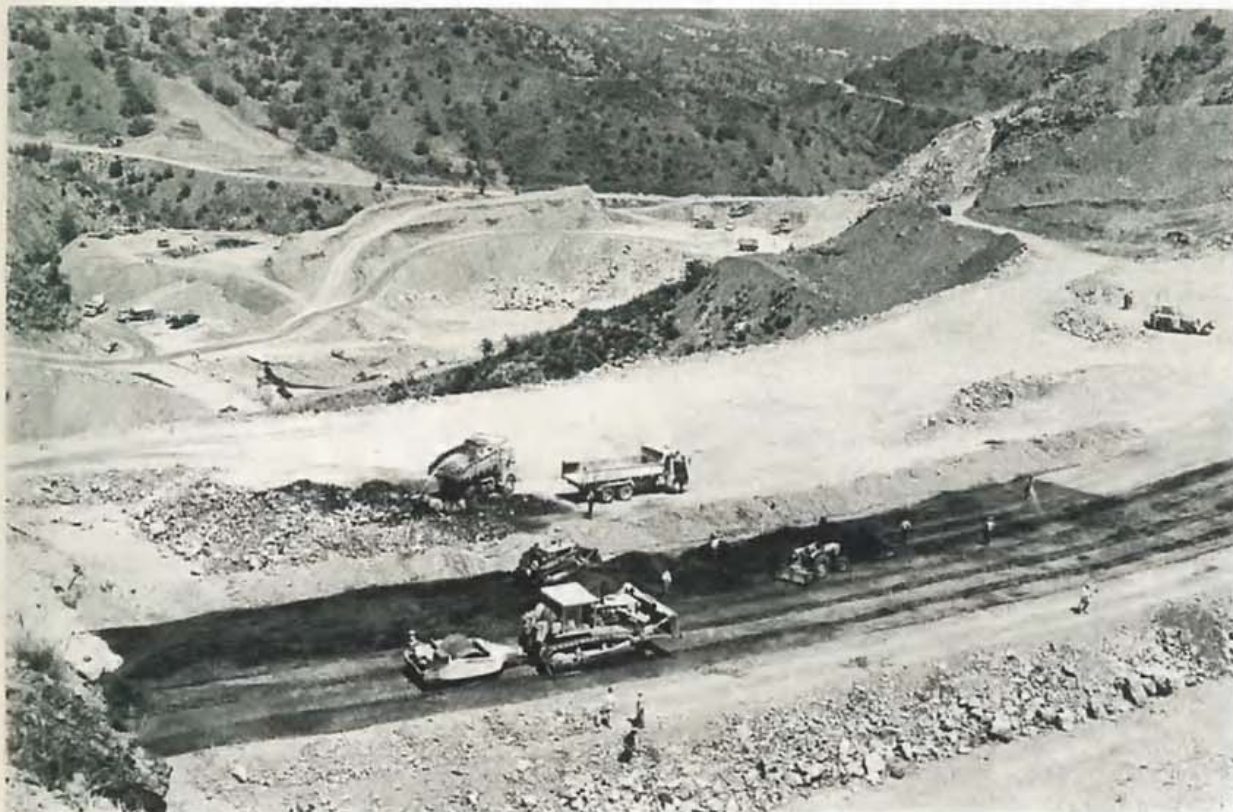
*Lefkara rockfill dam under construction.*

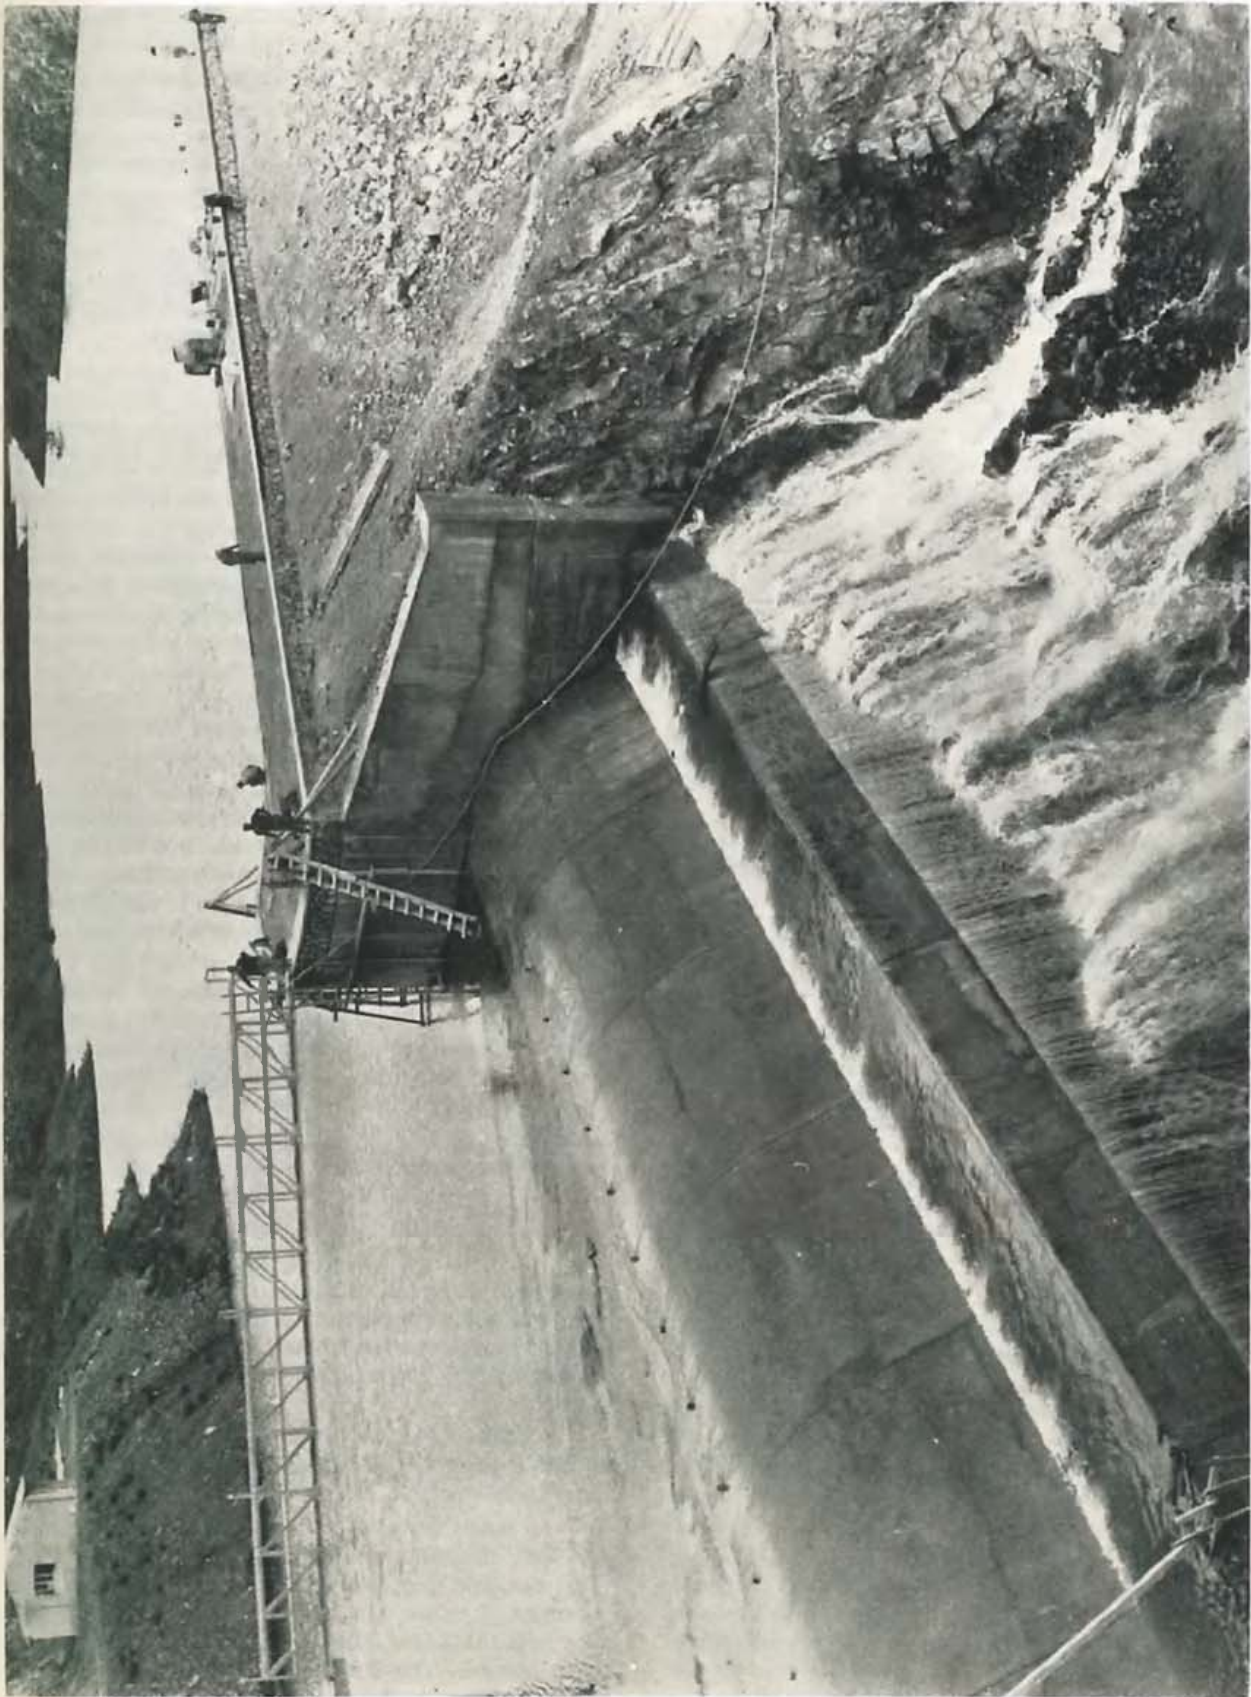
*The Argaka dam.*

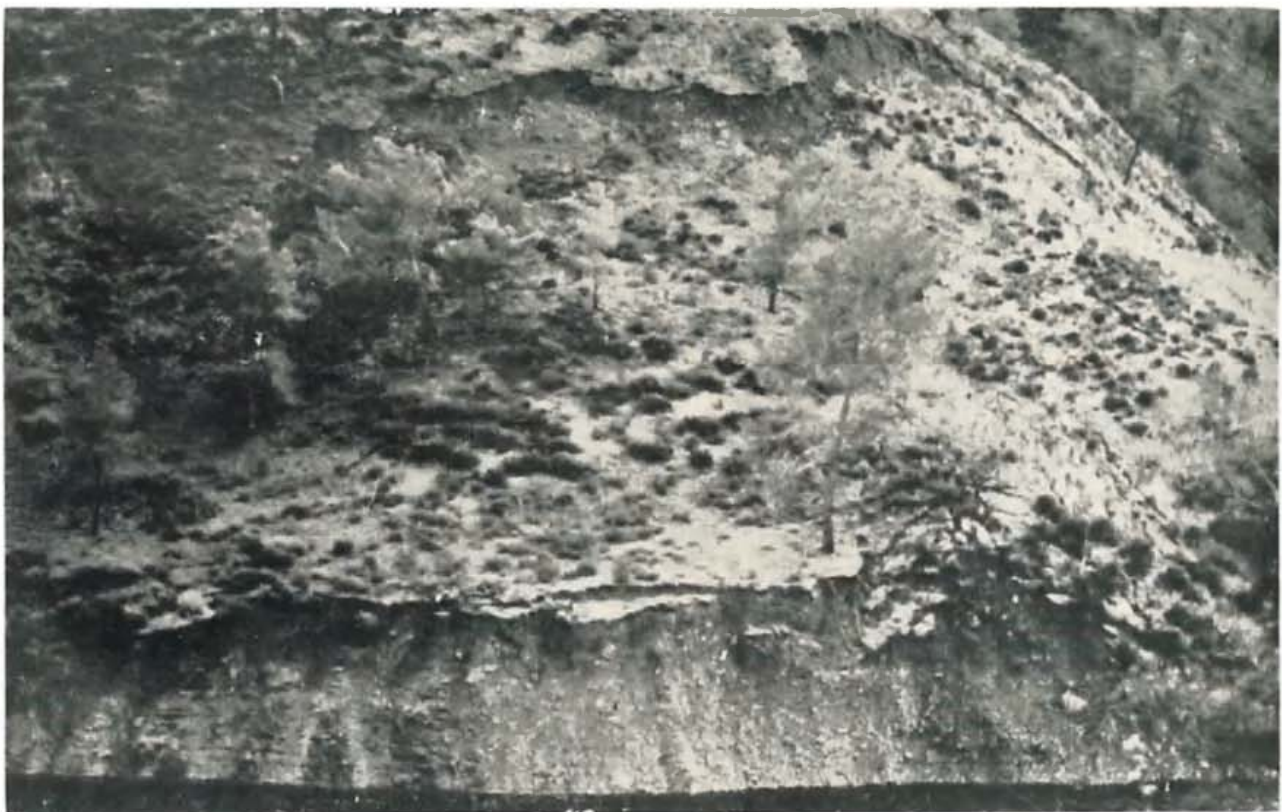
*Pomos dam reservoir. — Upstream slide area.*

Another post construction problem was the cracks in the reservoir which developed after the first impoundment in November 1966, on the right hand side at the tail end of the reservoir. Two slides appeared the lower one of which occurred because of the under-excavation for the borrow areas which rendered the slope unstable. This slide moved 3 m vertically with open cracks 0.9 m deep. This first slide triggered the second one immediately above it opening cracks up to 0.5 m depth.

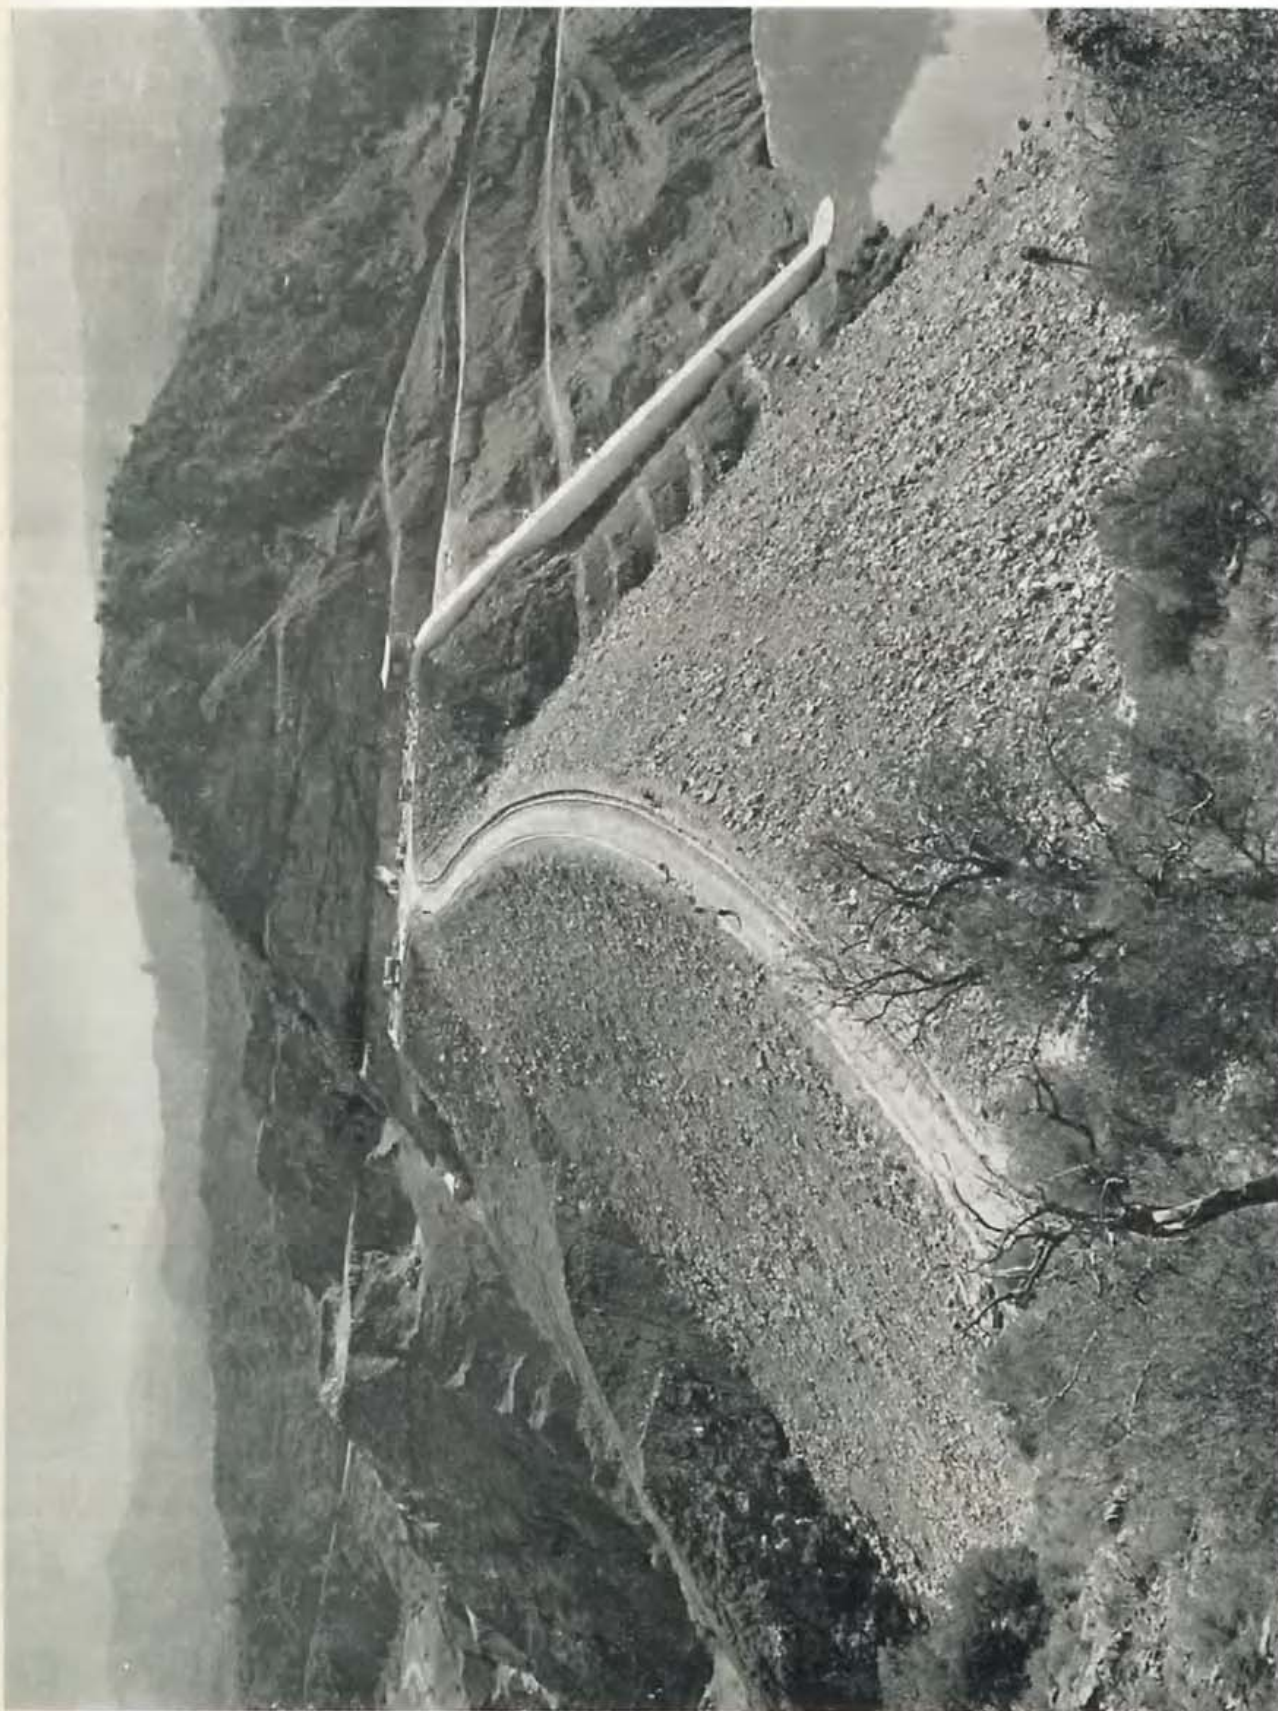
The Iefkara dan.

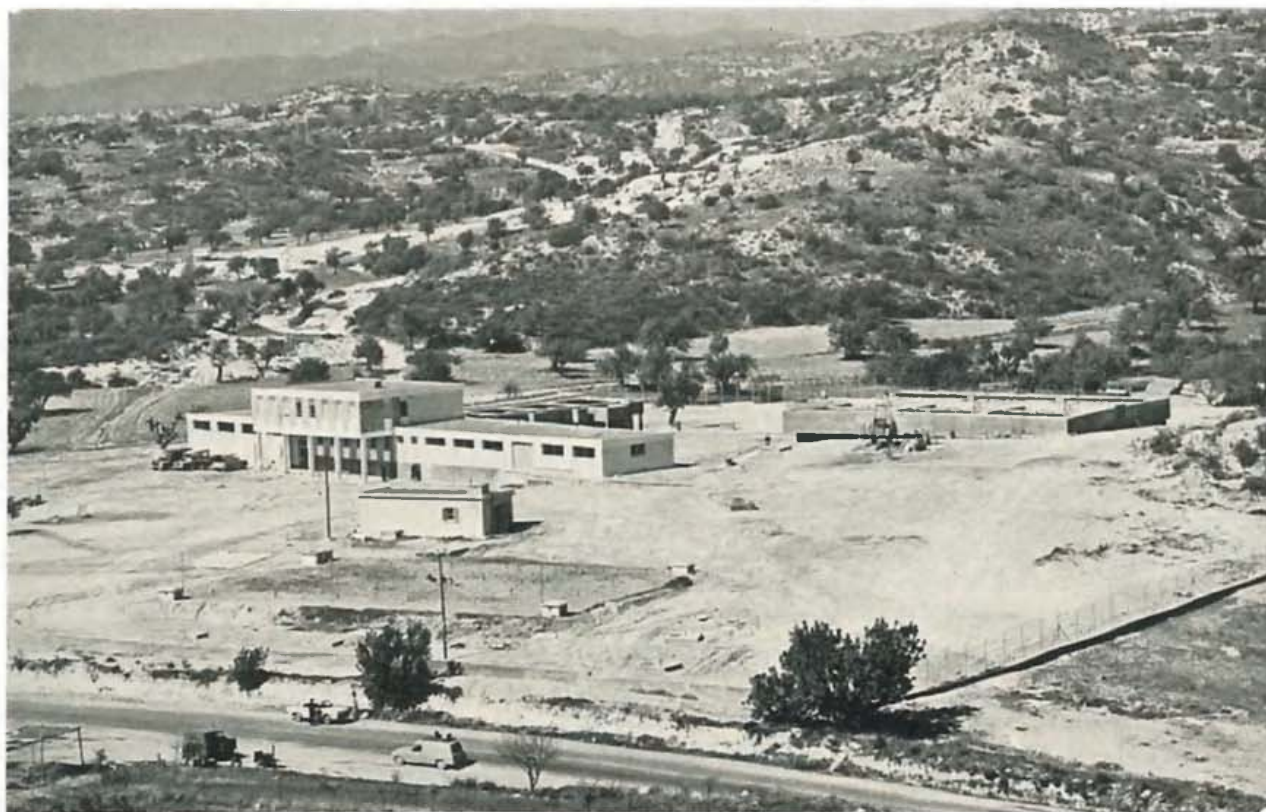
*Khirokitia water treatment plant.*

main Nicosia—Limassol Road. The pipeline was designed and laid by WDD whilst the Water Treatment Works were designed by Howard Humphreys & Sons of the United Kingdom and constructed by WDD. The Electrical and Mechanical equipment were supplied by Messrs United Filters Engineering Ltd., of the United Kingdom and have a maximum capacity of 20,300 m<sup>3</sup>/day with provision of extending the works to produce an ultimate output of 31,800 m<sup>3</sup>/day.

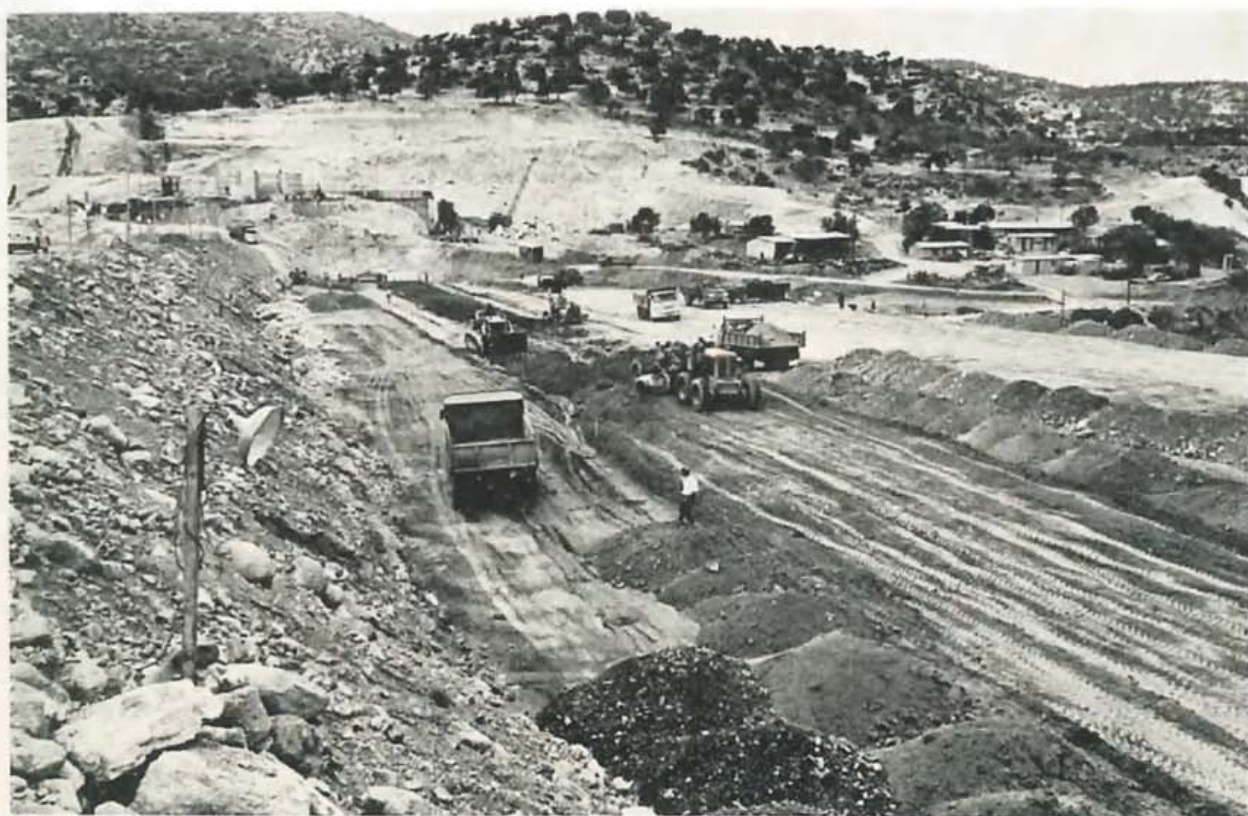
*Yermasoyia dam under construction.*

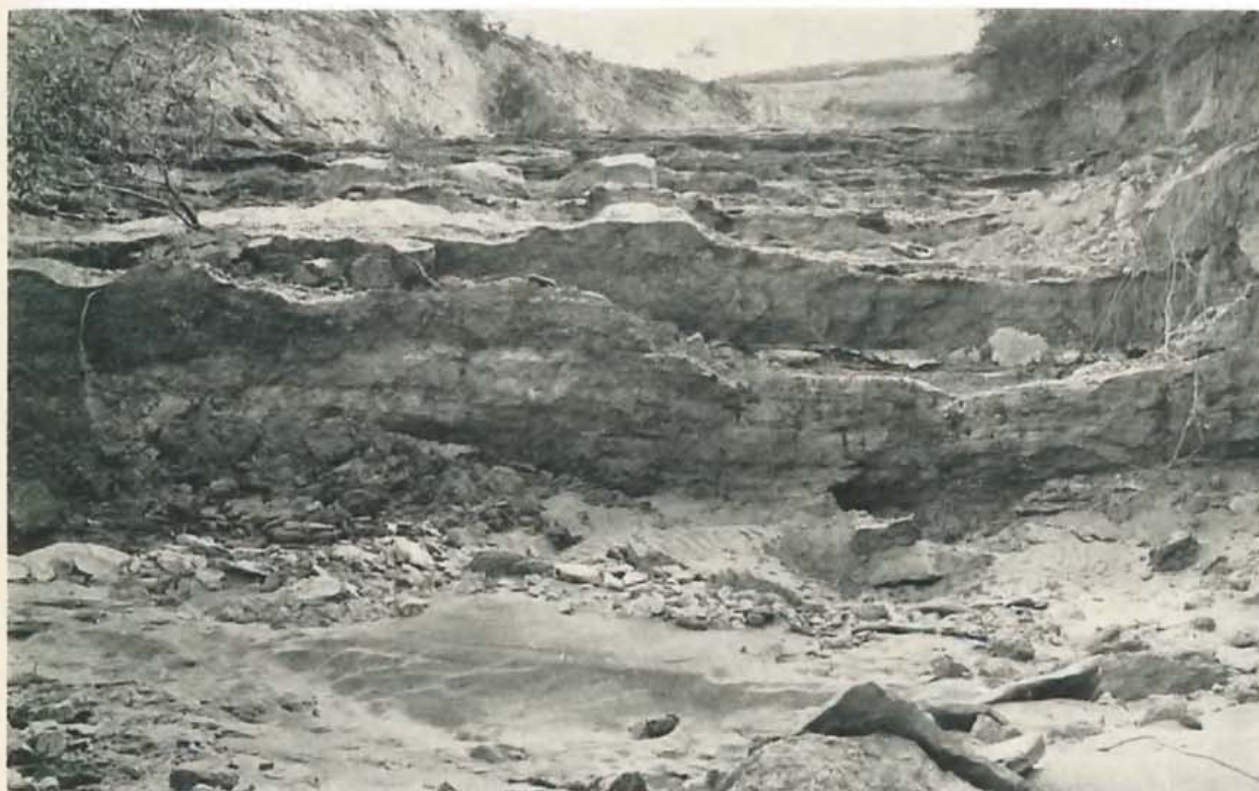
*Erosion of unlined spillway.*

Another interesting aspect was that during the big flood in 1969 damages occurred to the earth spillway and as a consequence the crest was built in concrete and the downstream chute was formed by excavation and its sides planted with acacia trees to stop erosion. The cost of this work reached about £900.

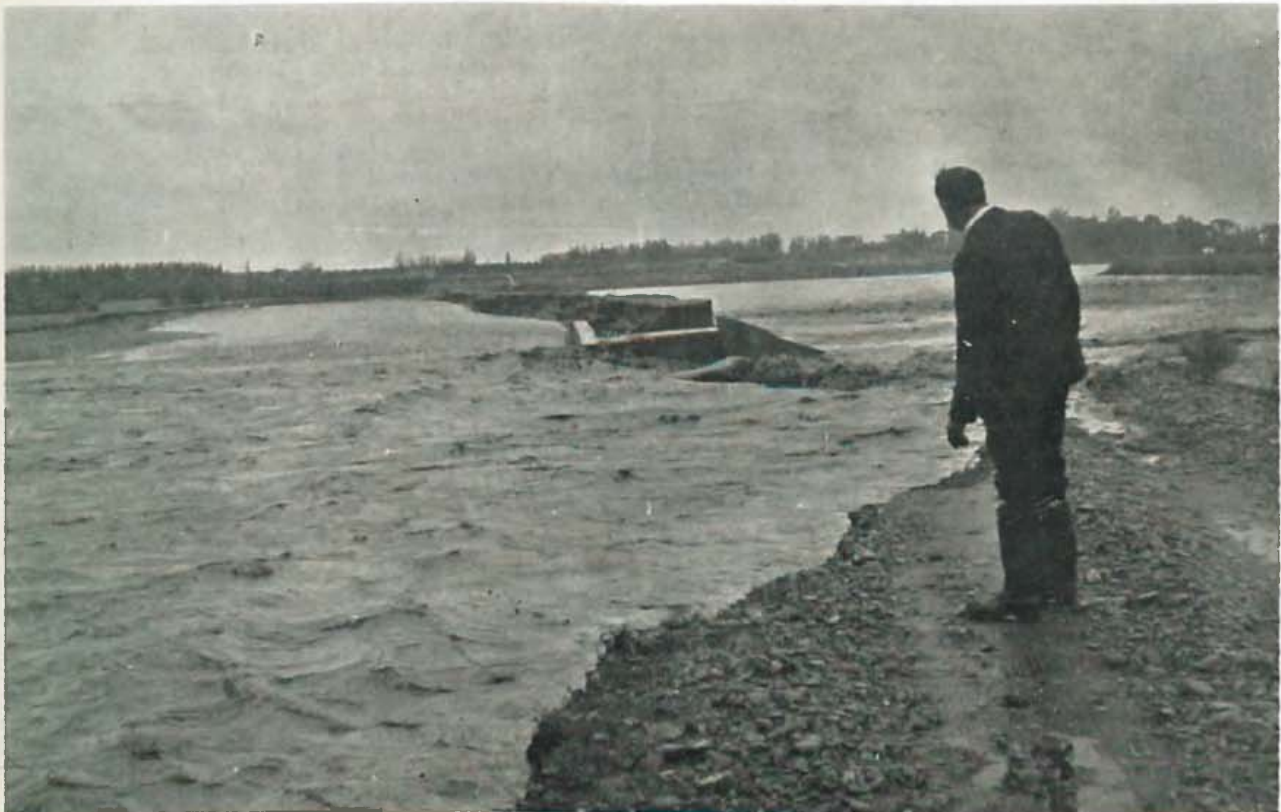
*Overflowing spreading grounds on the left with flooded river course on the right.*

As this dam is built on a major river it is bound to receive a considerable load of sediment which in a few years would render the reservoir bed impermeable. A series of spreading grounds were provided downstream of the dam in which clear water from the dam would be diverted for infiltration and to increase the amount of water recharged. Two spreading grounds in series have been built just downstream of the dam of a total capacity 0.134 million m<sup>3</sup> at the left abutment utilizing part of the river bed, the river flow having been canalized towards the right abutment. The banks of these spreading grounds are of clay core with gravel zones on either side and their maximum height is about 3 m. They are interconnected by a concrete over-

The first inflow in the spreading grounds at the end of January 1968 was regulated at the controlling gate from the diversion weir to the reservoirs so that with an inflow of 1.5 m<sup>3</sup>/s, the maximum water level in the reservoirs was maintained thus reaching equilibrium between the rate of inflow and the rate of infiltration. As the surface area of the gravelly base of the reservoirs is about 40,000 m<sup>2</sup> the rate of infiltration is 2.8 m<sup>3</sup>/m<sup>2</sup>/day. This rate of infiltration shows that the infiltration through the spreading grounds was about 3.5 times that through the dam reservoir. The reasons for the highest rate of infiltration can be attributed to the fact that water applied on the spreading grounds contained much less silt than the water in the dam reservoir, and that the gravel bed of the spreading grounds was made up of coarser gravels containing less silt than the dam reservoir.

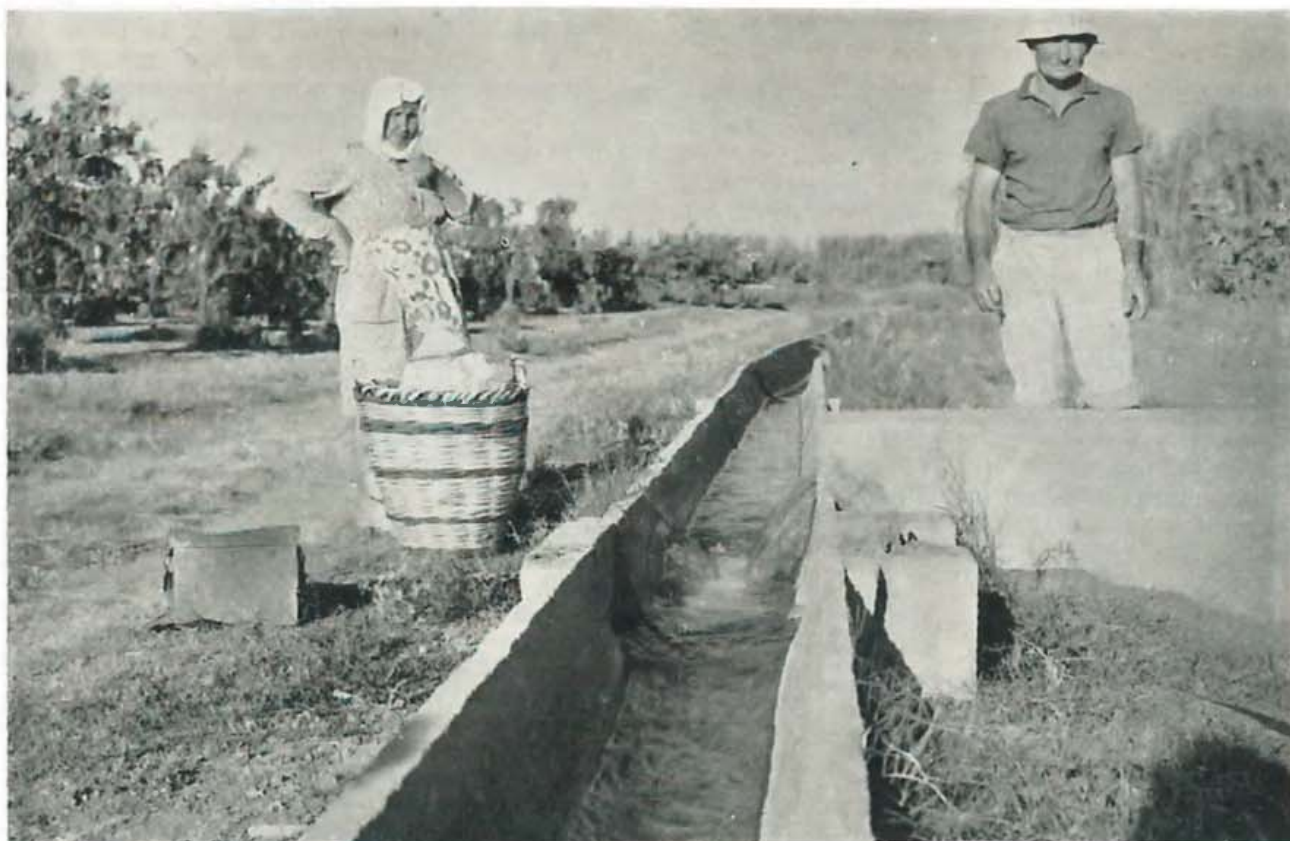
*Precast concrete polycentric irrigation channels at Morphou.*

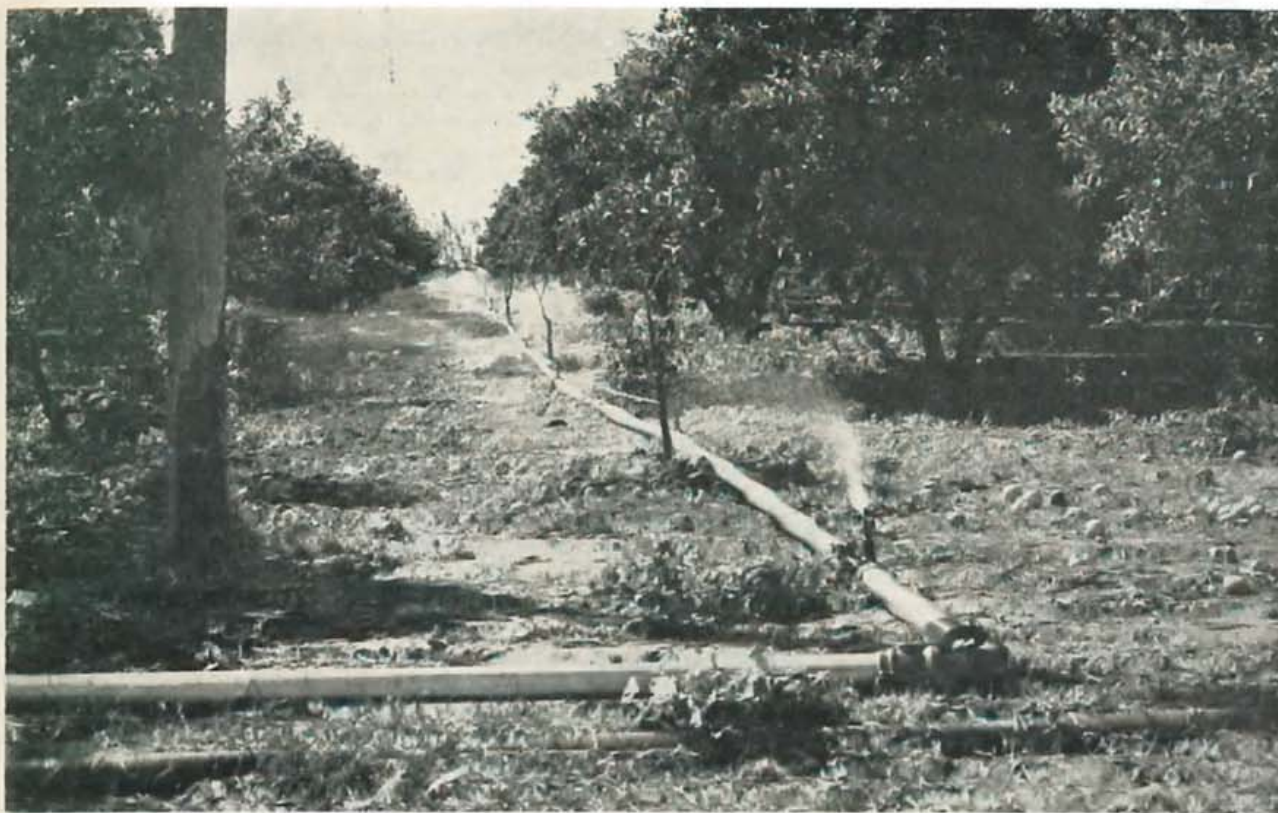
*Sprinkler irrigation of citrus at Morphou.*

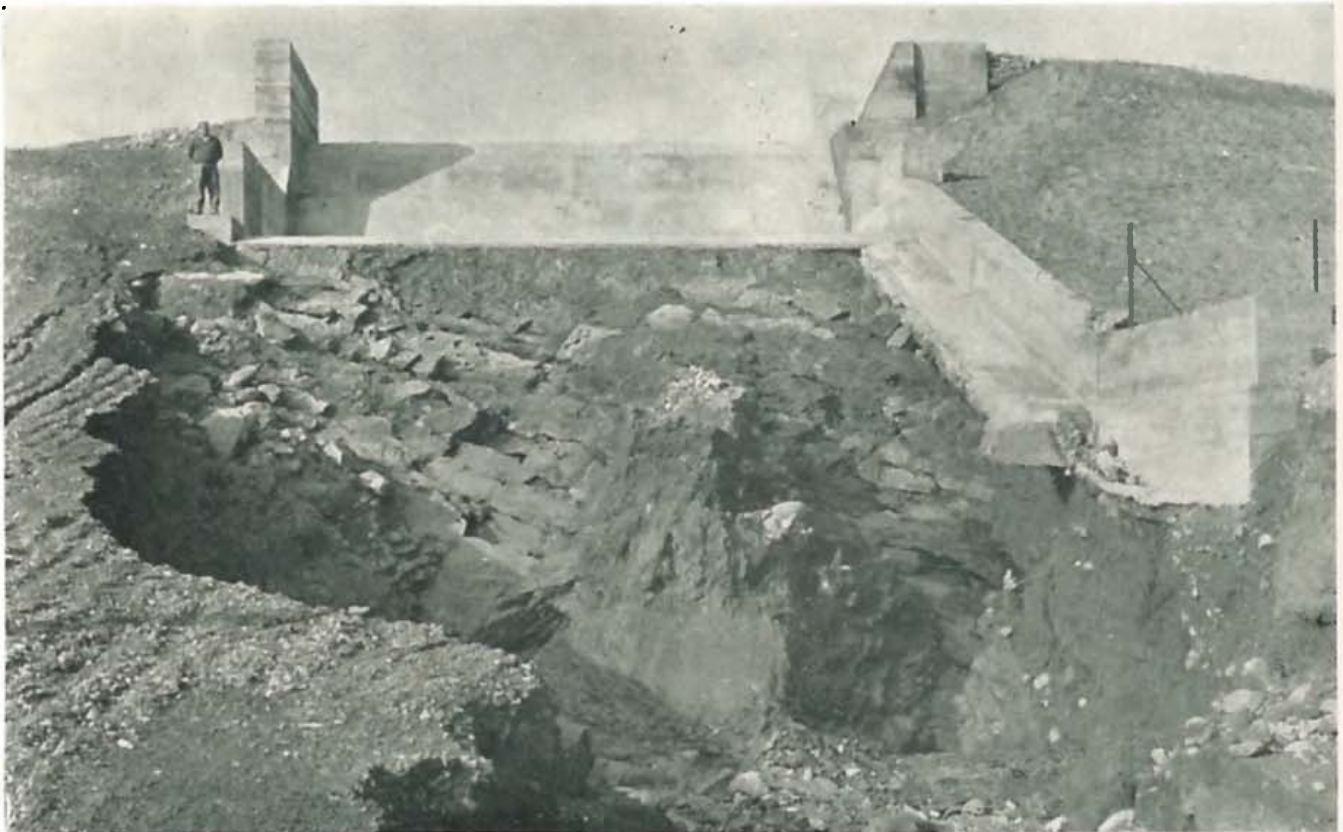
*Erosion of spillway unlined channel.*

Another problem was the erosion of the soft sandstone bedrock of the spillway channel which was subsequently lined in concrete.

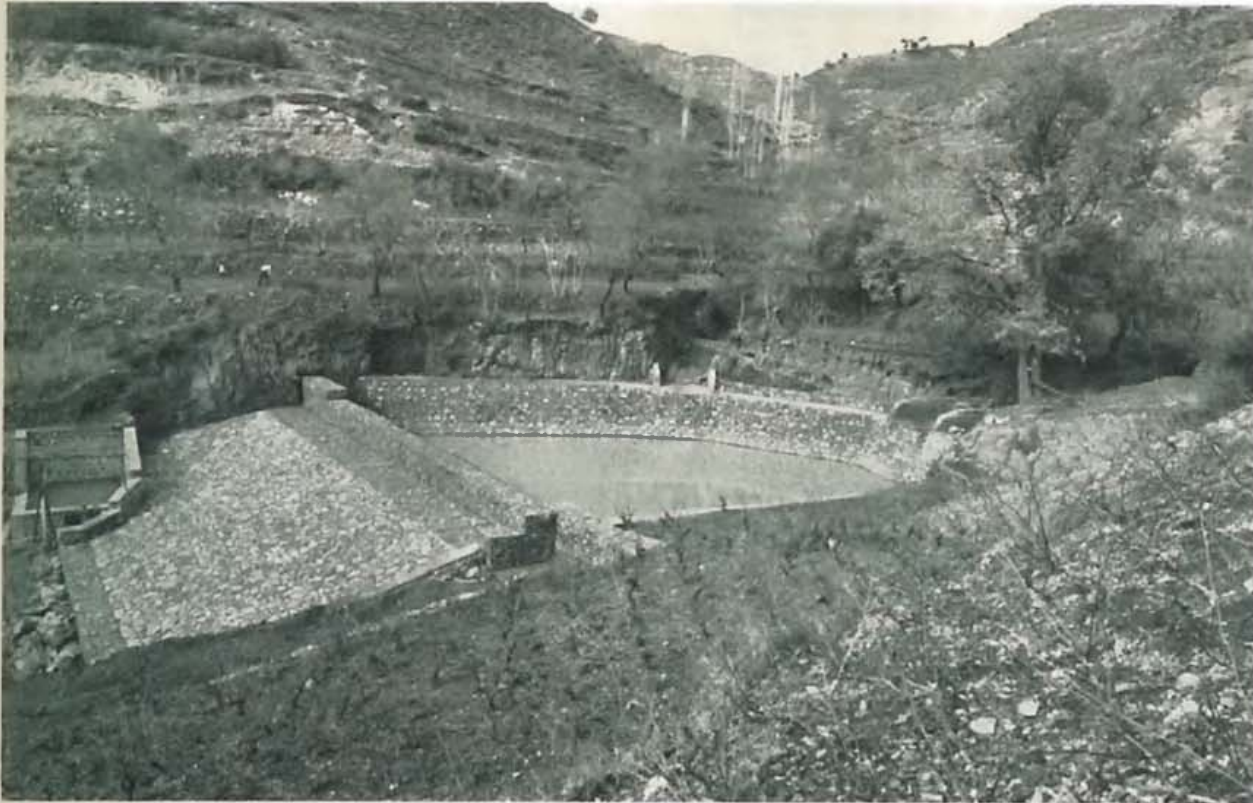
*Silt trap upstream of Agros dam.*

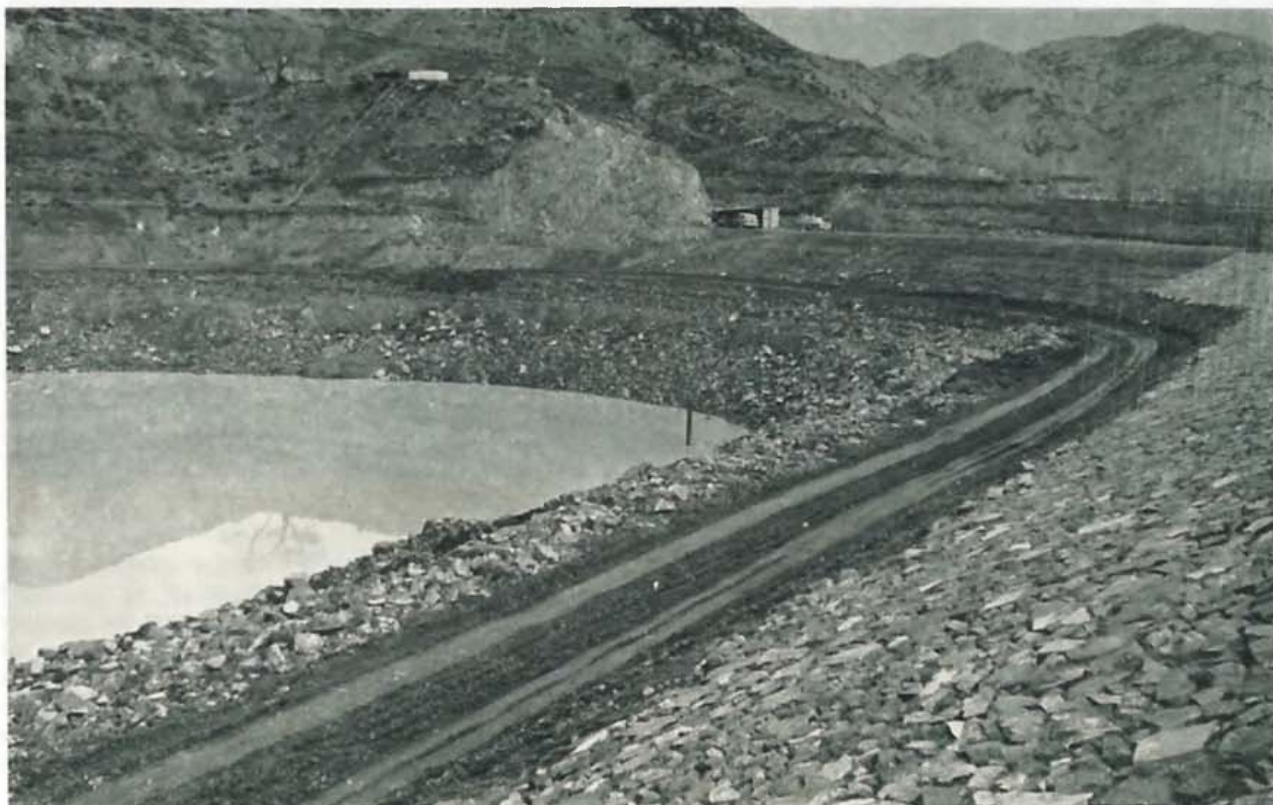
*Clay blanket on original rip-rap.*

The following years showed that the seepage through the reservoir side continued at the same rate. It was therefore decided to apply a clay blanket in the reservoir which was found to be the cheapest solution for reducing the losses.

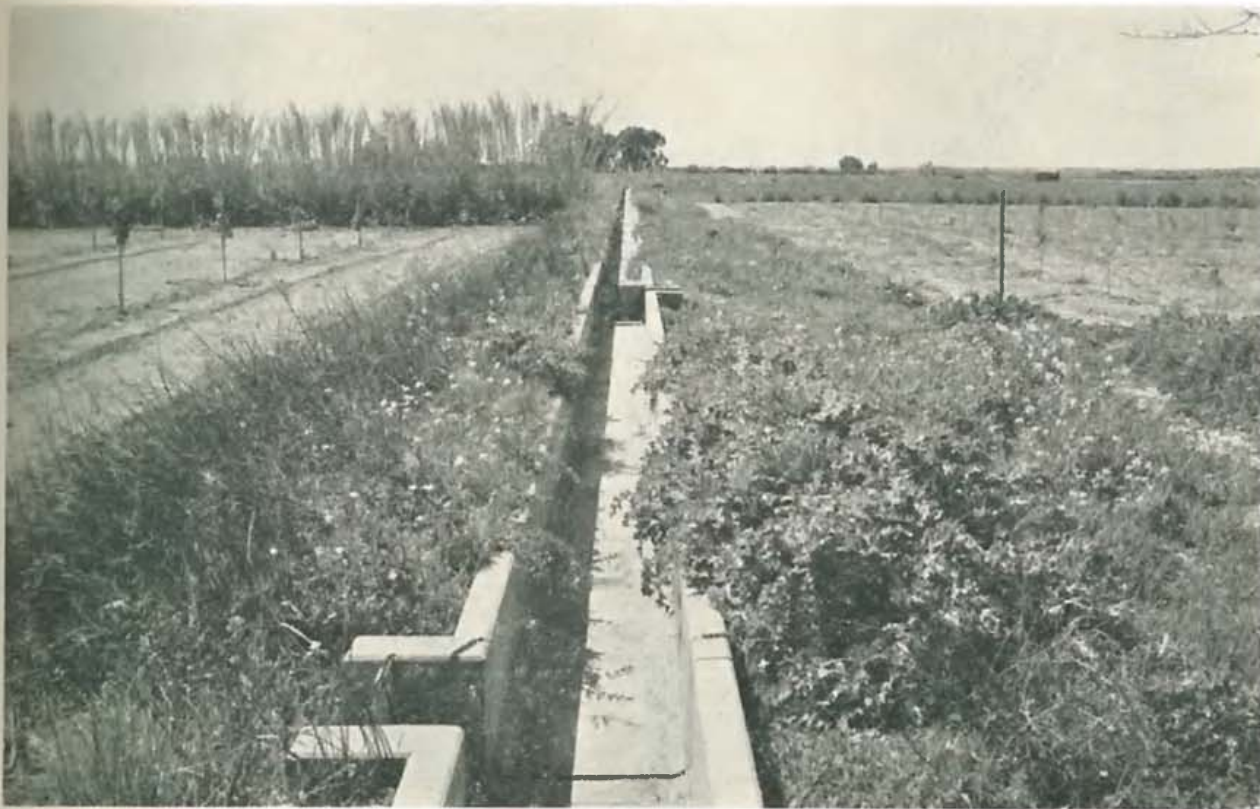
*Rectangular R.C. irrigation channel.*
