# ***DAMS OF CYPRUS***

***Water Development Department***

***NICOSIA - CYPRUS  
1974***

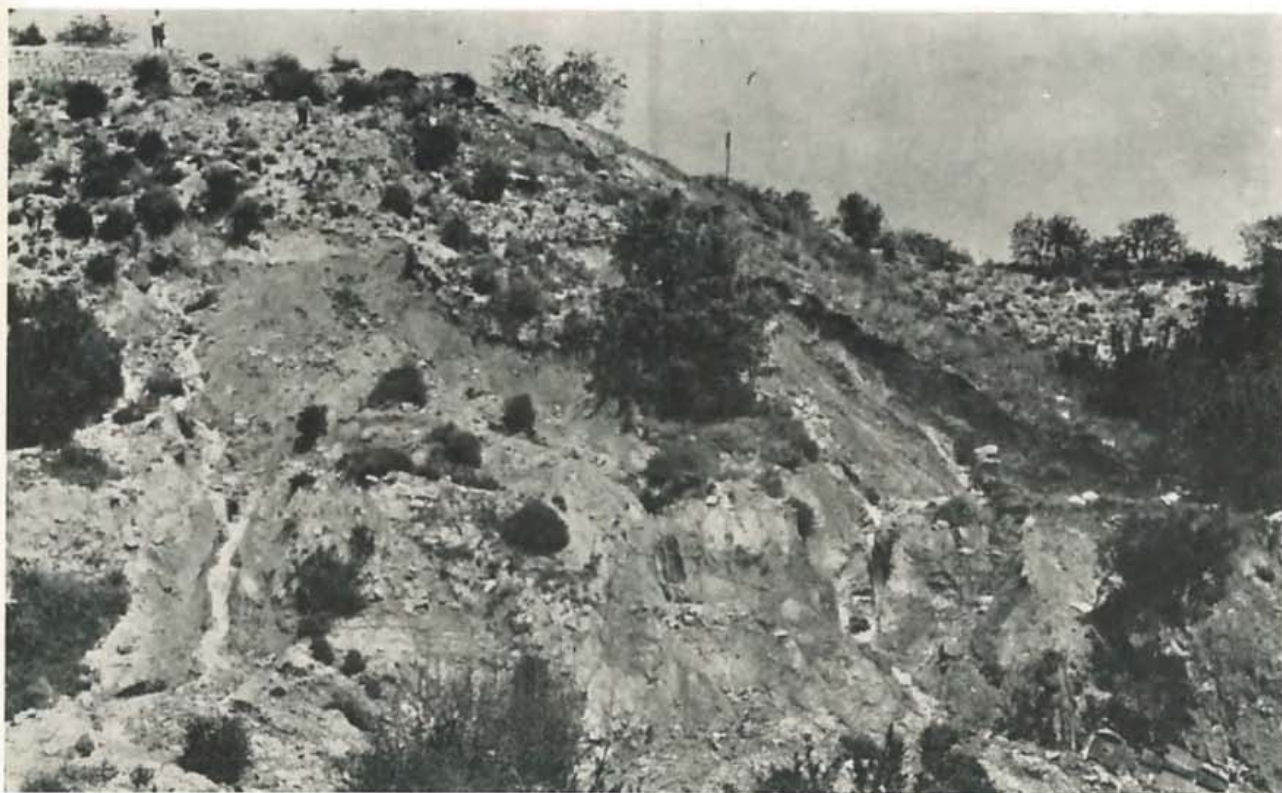
*Extensive seepage with landsliding on the East abutment.*

As already indicated the main problem of this dam was the excessive leakage from the East abutment which was due to the big cavities in the Pakhna For-

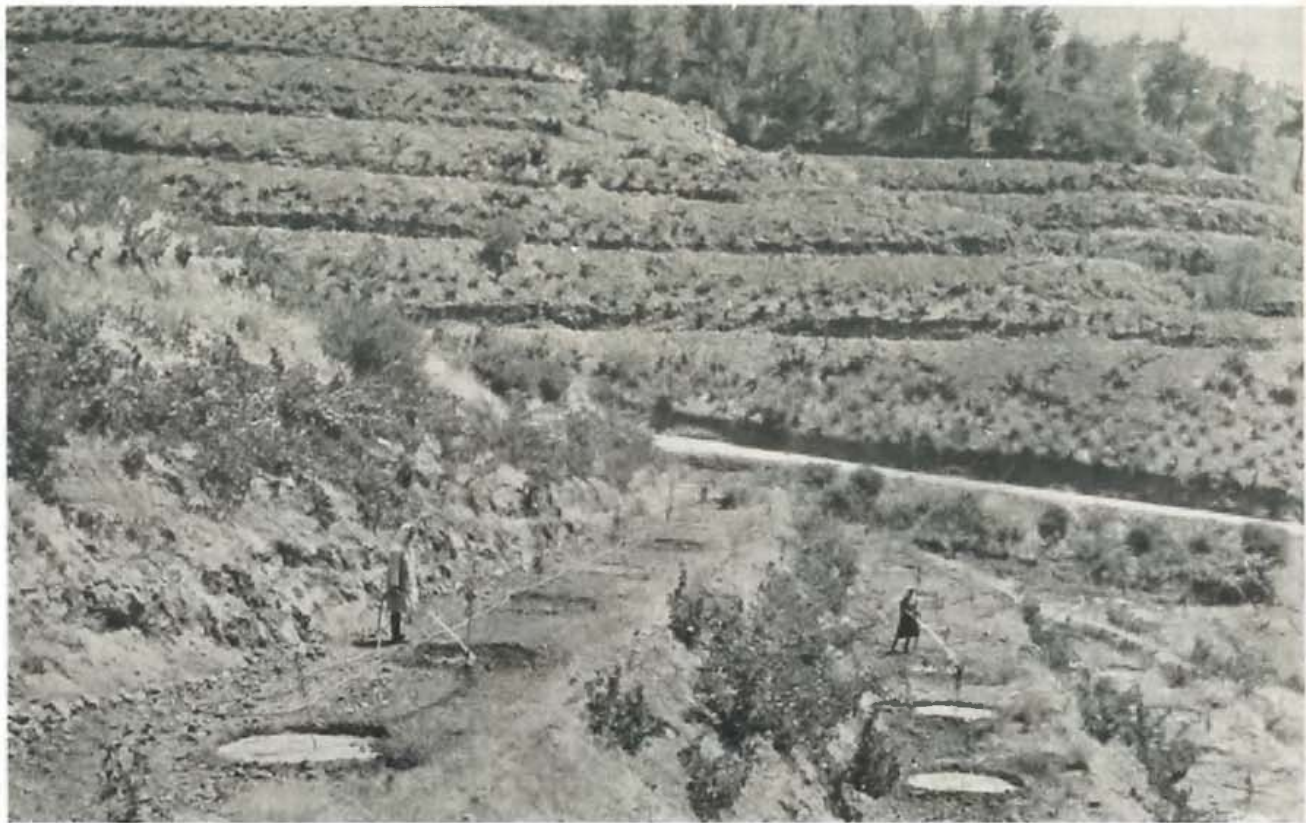
*Hose-basin irrigation of deciduous trees planted on terraces.*

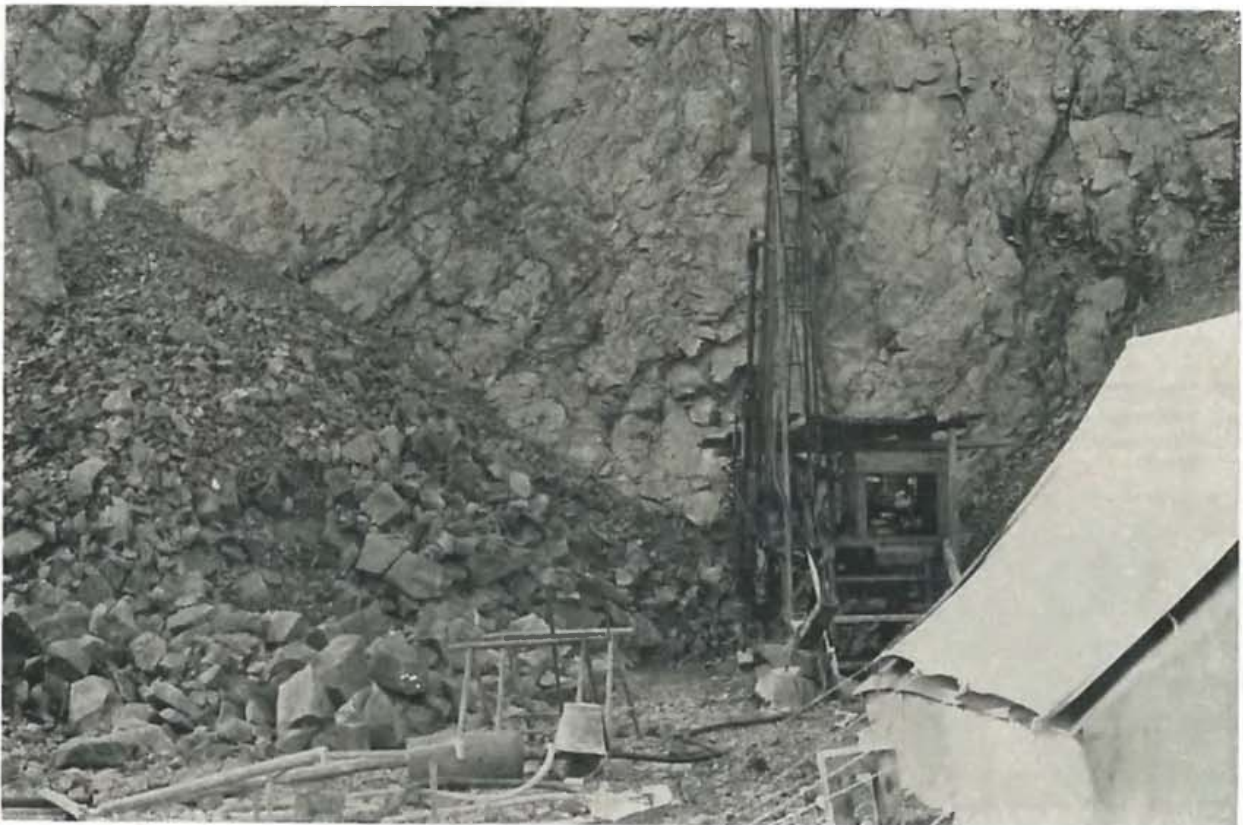
*Drilling and grouting on the West abutment. Weathered and sheeted diabase rock can be seen.*

In an effort to see whether the seepage of the West abutment could be reduced by further grouting works, considerable investigations were carried out through drilling, coring, water testing and test grouting. From the cores recovered, it became evident that the rock was broken in most parts and shear zones exist right down to a depth of 70 m from the crest.

The permeability of the rock in lugeons varied from 4 to 106. Due to the extensive shear zones it appears that better rock can be found only in considerable depths below what can be grouted economically and it therefore seemed improbable that any further grouting works could be justified.

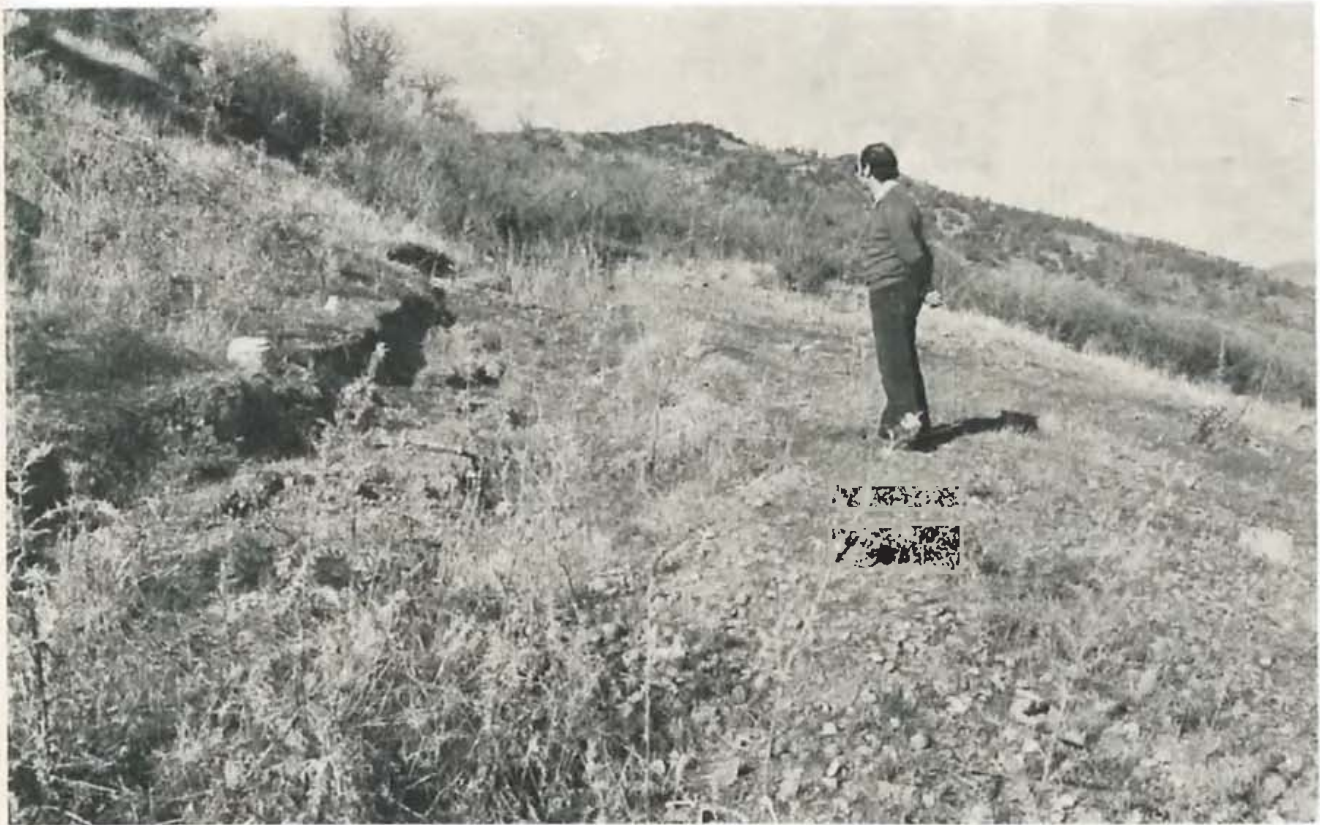
*Crack on the overburden overlying the diabase of the Western flank.*

detached unit appears to be the result of a gravity slide. The cracks were first observed in the talus immediately after the first impoundment. The major crack can be easily traced for about 650 m without any breaks in its continuity with a maximum vertical movement of about 1 m. A number of trenches were excavated across the major fault which revealed that the hard diabase was overlain by 0.15–0.30 m of fault breccia made up of angular fragments indicating movements under high pressure. A clay slip surface with slickensides was met at the junction of the fault breccia with the talus which indicates movement in the direction of the dip, with clear indication that the talus moved in respect to the underlying diabase by sliding on the clay slip surface. The question arose whether the movement which occurred was associated with the

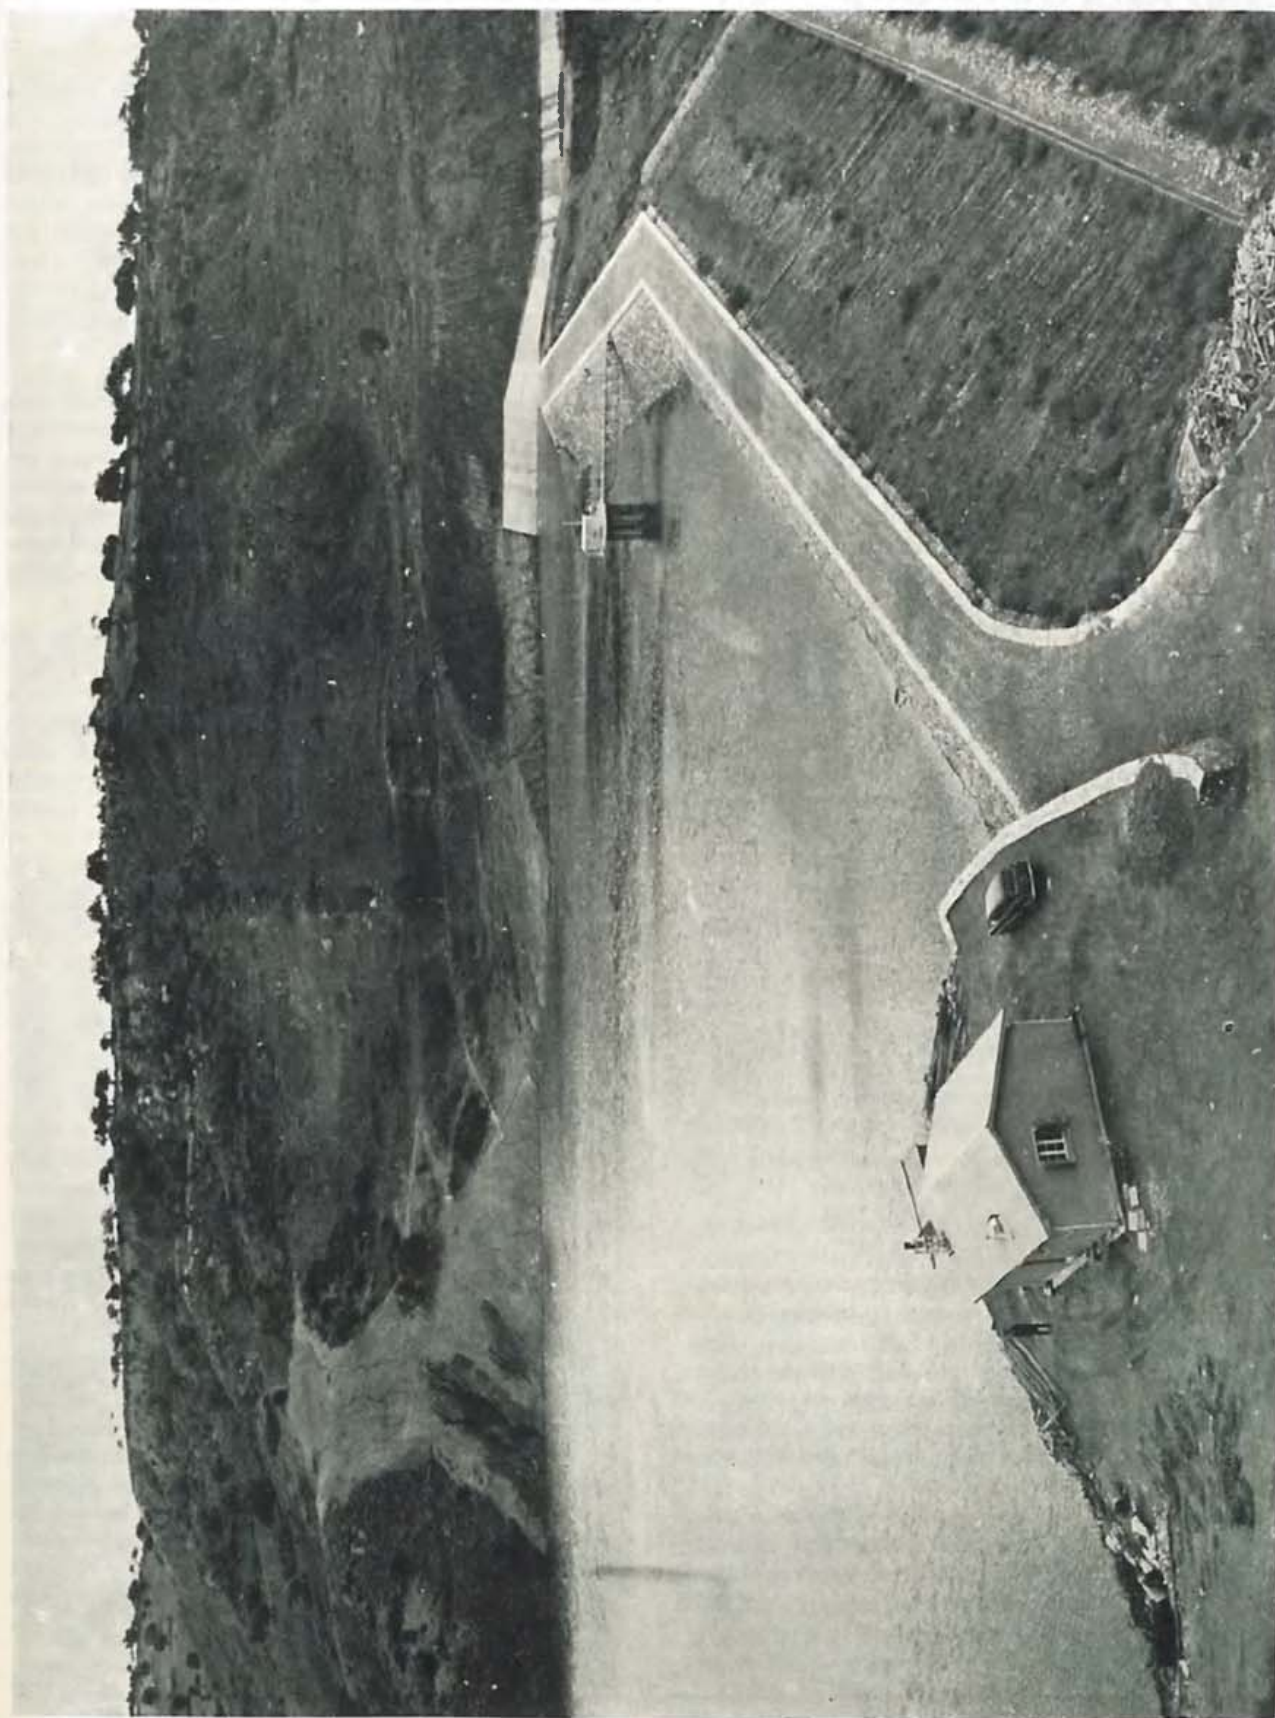
The Mavrokolymbos dam.

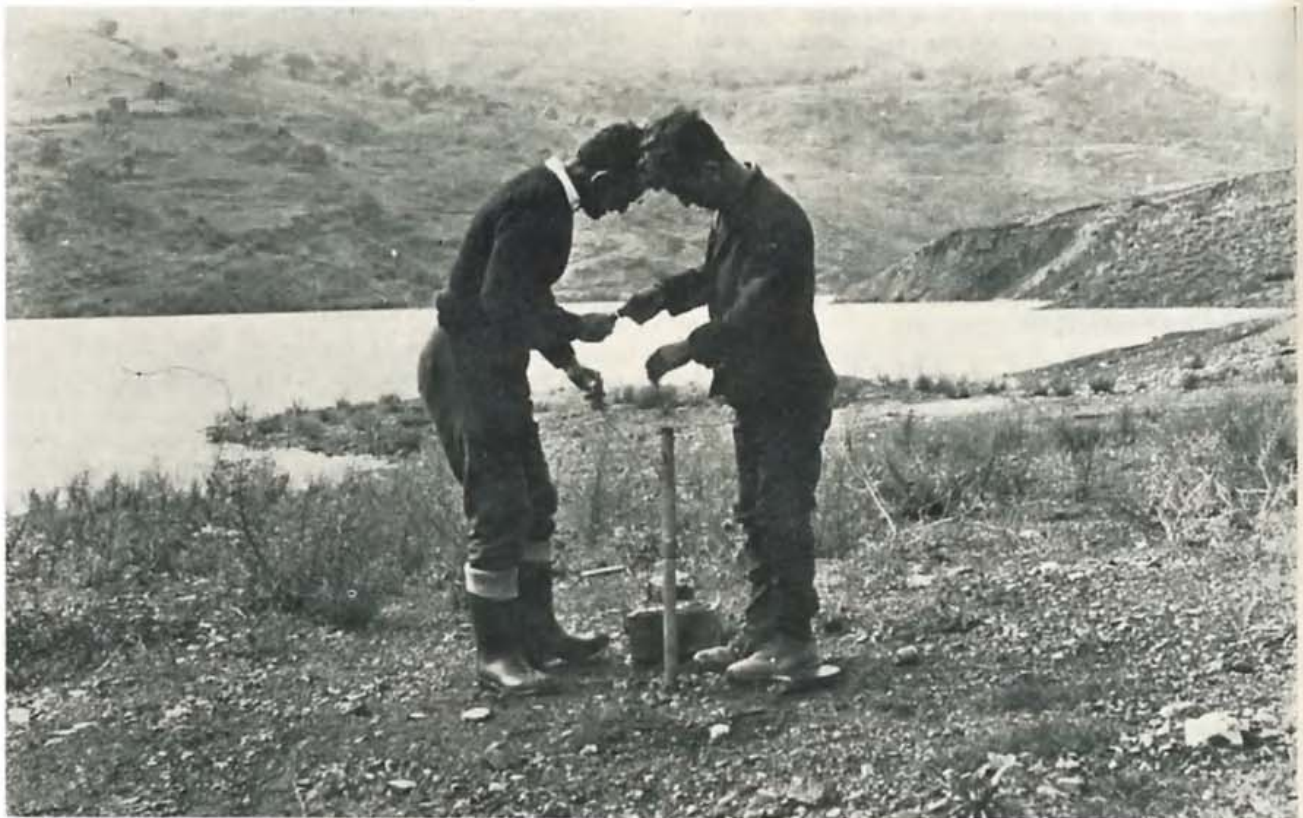
*Piezometric observations on the right abutment.*

At river bed level six pore pressure and five total pressure cells. At the same section at 13 m higher two pore pressure cells. At the second section on the right abutment and at an elevation of 13 m above river bed level, six pore pressure and three total pressure cells, whilst in the same section and at 12 m higher two more pore pressure cells were fixed. Thus a total of 16 electroacoustic manometers for pore pressure measurements and 8 tensiometric cells for total pressure measurements were used.

All cables connected with the instruments were placed through steel pipes leading up to the permanent guard house where they are connected to a control box, thus enabling the measurements to be taken from the house.

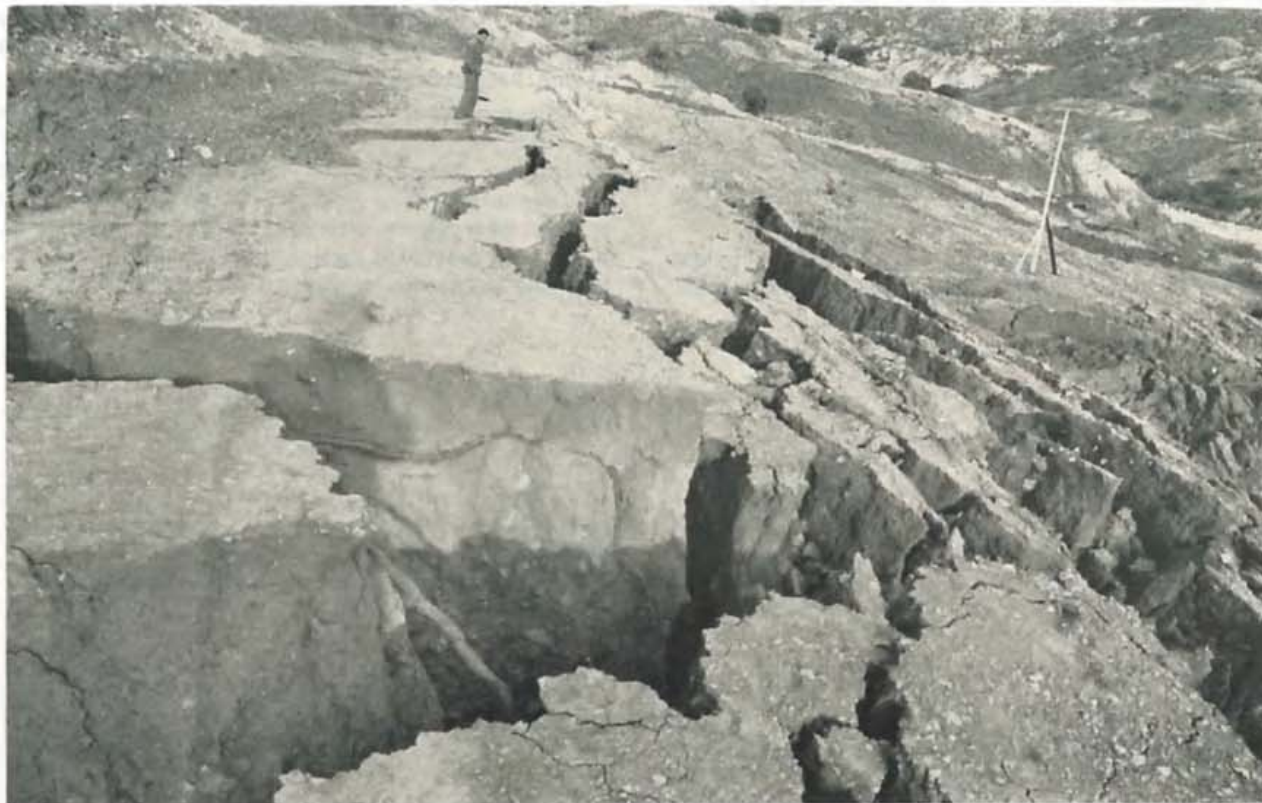
*Reservoir slide area on the right abutment.*

That the old slides on the right abutment are the results of weathering of the underlying shales, and that these slides were reactivated by the oversteepening of their toe by under excavation during construction and by water pressure due to the rainfall of 1965—1966. The natural slopes of the ground being 10° to 16° give a factor of safety against sliding of 1.2 which would decrease to 1 under wet conditions. So with the undercutting of the toes and an increase in the moisture content, the surfaces become very unstable. Although such landslides within the reservoir do not alter the capacity, yet the possibility of triggering more landslides from outside the reservoir was estimated that it might result to about 340,000 m<sup>3</sup> or 15% reduction of the reservoir capacity.

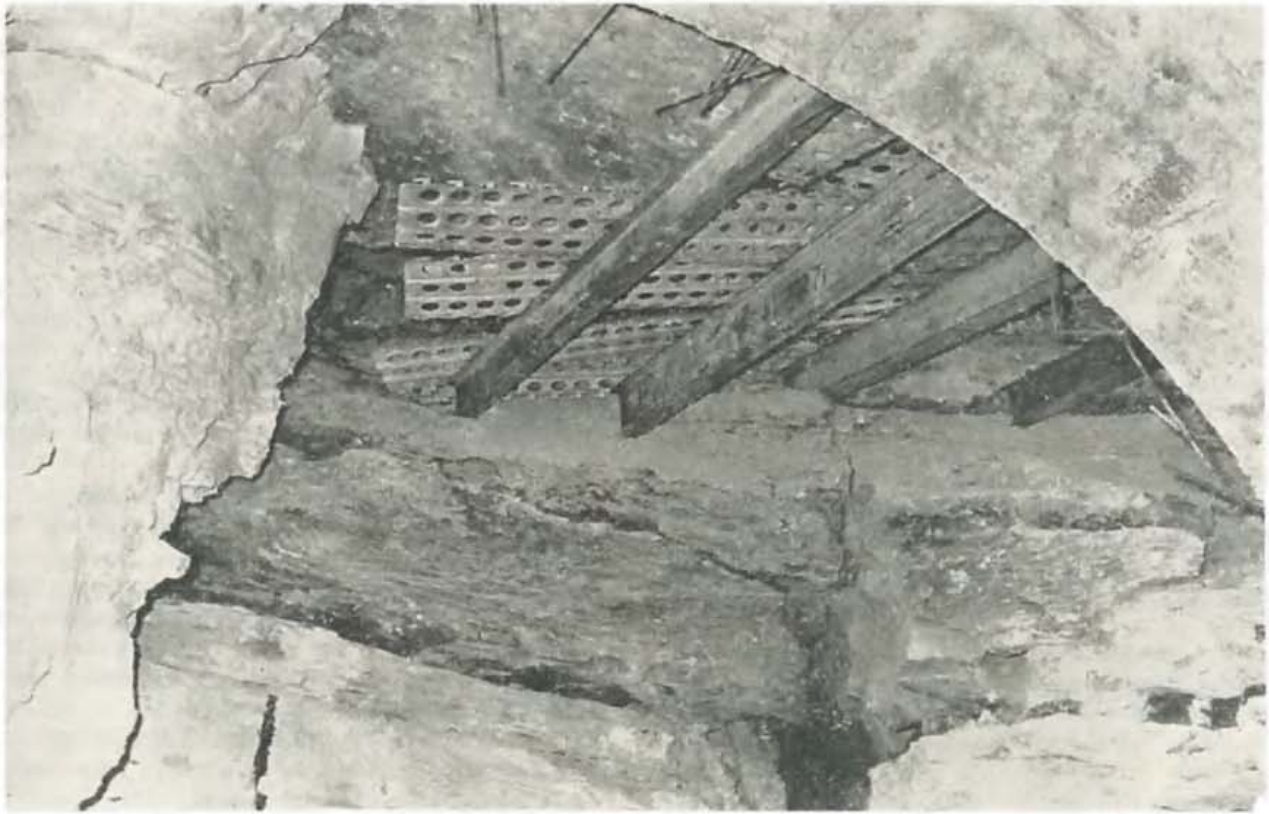
*Excavation of tunnel showing solution channels in the sandstone.*

cause of the extensive solution channels and cracks of the Pakhna Formation. In particular the East curtain had to be extended much more than originally estimated in view of the many cavities and channels met during construction.

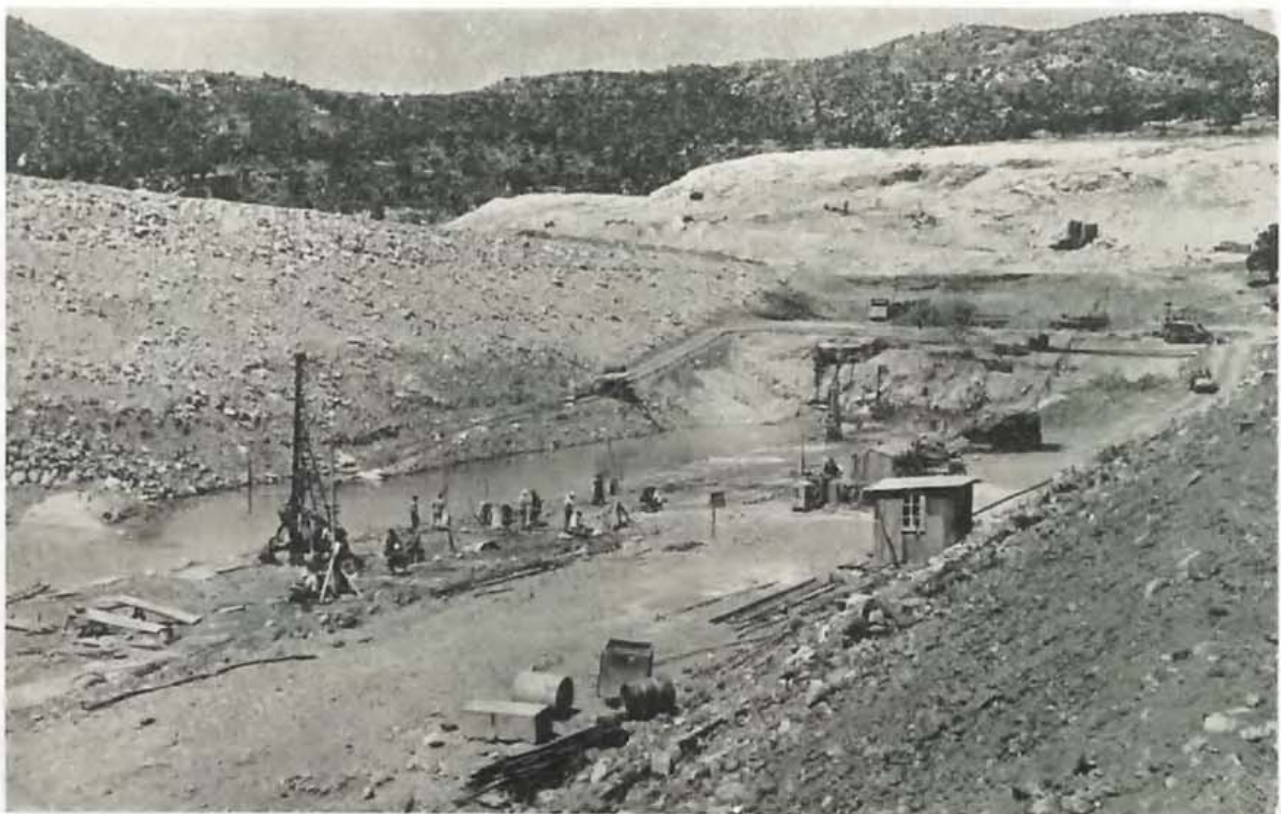
*Cut-off trench excavation with alluvial grouting.*

In view of the depth of the alluvium and of the amount of seepage, it was decided that the best method for making a permeable foundation curtain would be by alluvial grouting using chemical grouts as well.

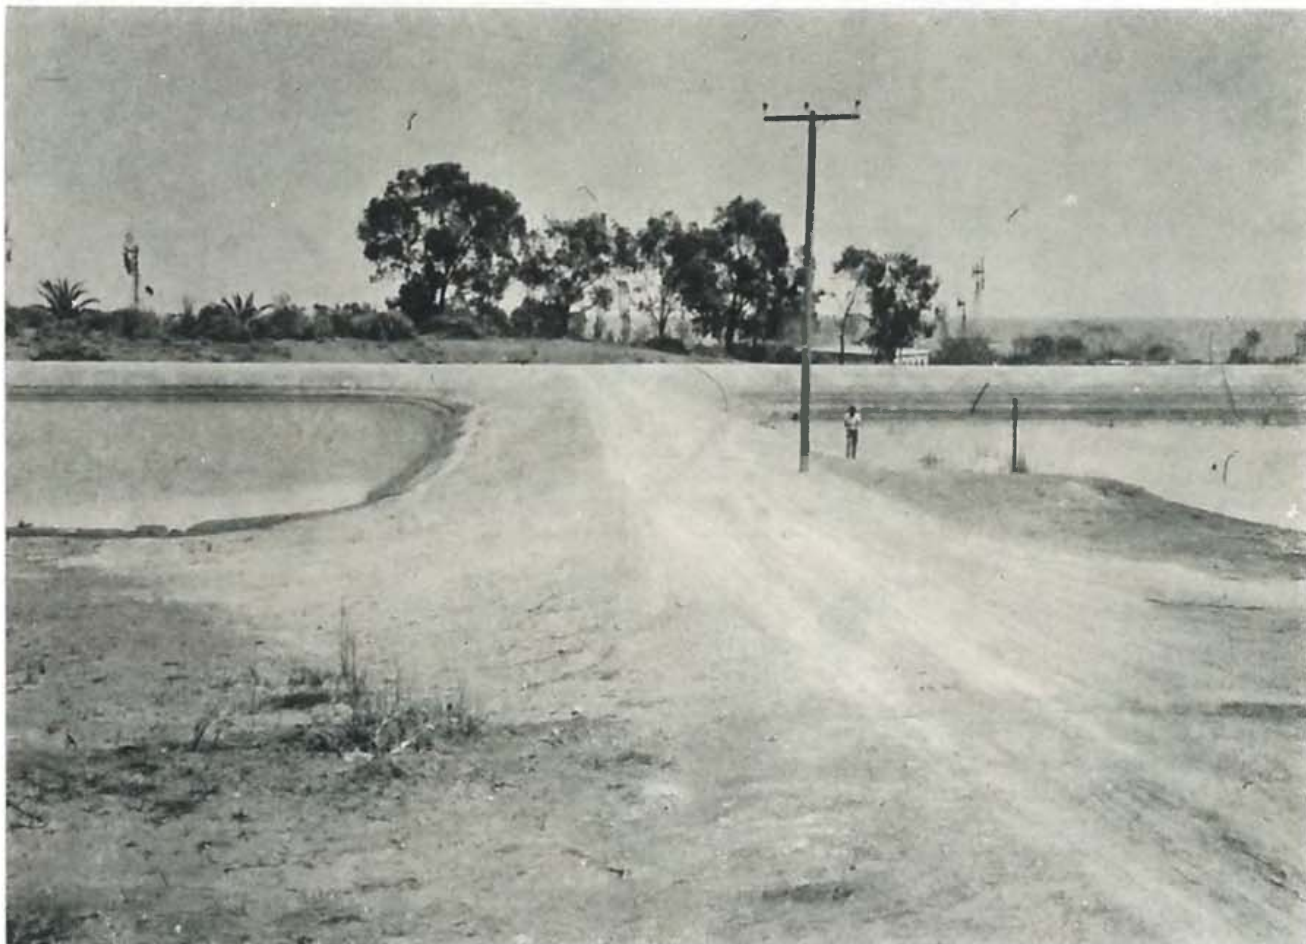
*Ayios Memnon spreading grounds.*

In view of the problems described above, in connection with the infiltration tunnel and the deterioration of the quality of the water in storage with time, it was decided to build expensive spreading grounds at higher levels where land was available and pump the water there for recharge. This system, whereas expensive, yet would expedite the recharge through a more efficient system. Also the siting of the various spreading grounds was selected in such a way as to give a more uniform recharge through the aquifer. In addition

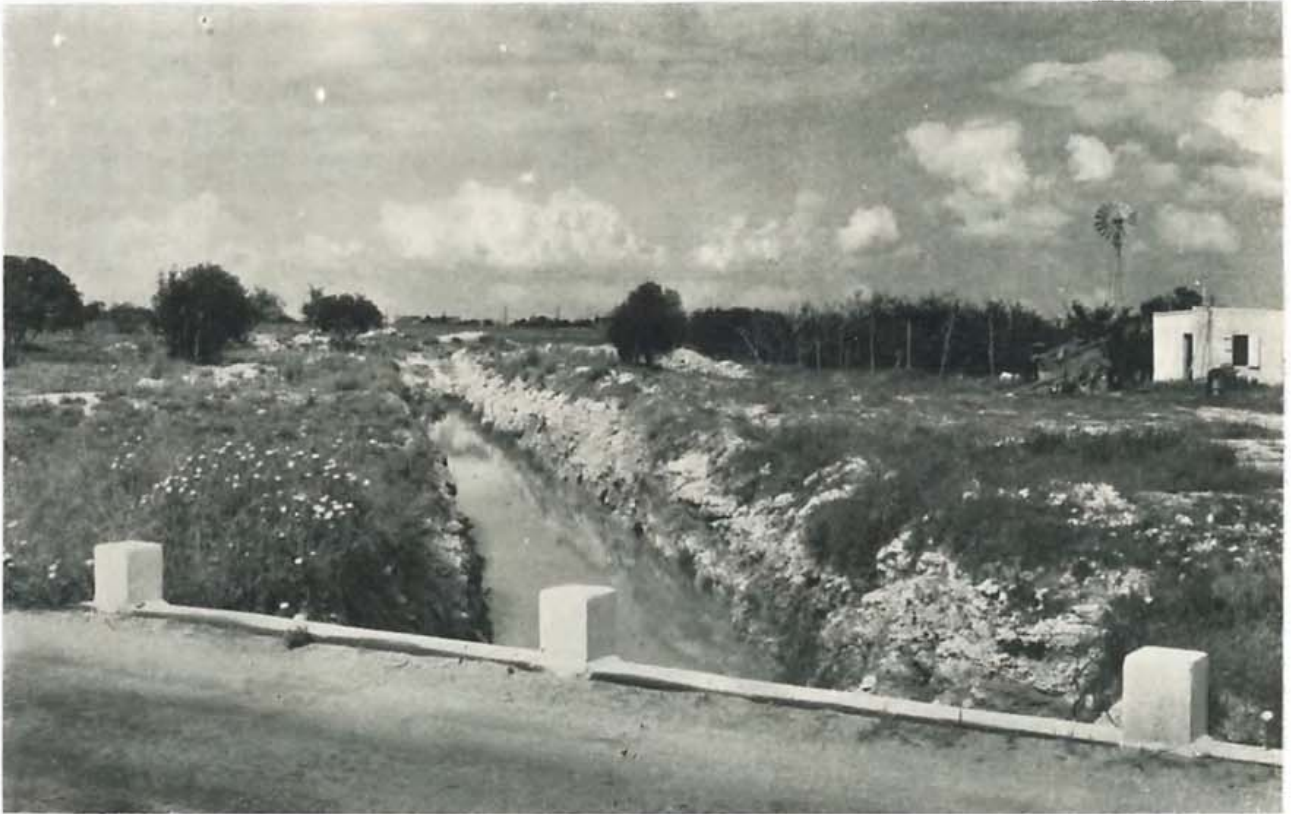
*The Paralimni lake recharge conveyer canal.*

For the above reasons, recharge works have been carried out consisting of a major storage at Paralimni Lake of about 2.3 million m<sup>3</sup>. of 35 small recharge dams situated at suitable sites along the stream valleys and of a conveyor recharge canal 11 km length, gradient 1/1000, which conveys water from the lake to the recharge dams and also infiltrates water along its length throughout its unlined section 3x4 m excavated on the calcarenite. The rate of infiltration along the canal has been estimated to be about 5,000 m<sup>3</sup>/day. Water can also be supplied from the recharge dams into the canal as may be required. The total storage capacity of the 35 recharge dams is about 0.20 million m<sup>3</sup>. The works were carried out in 1963 at a cost of £34,000 and until 1973 they received water three times of a total quantity of 4.5 million m<sup>3</sup>.

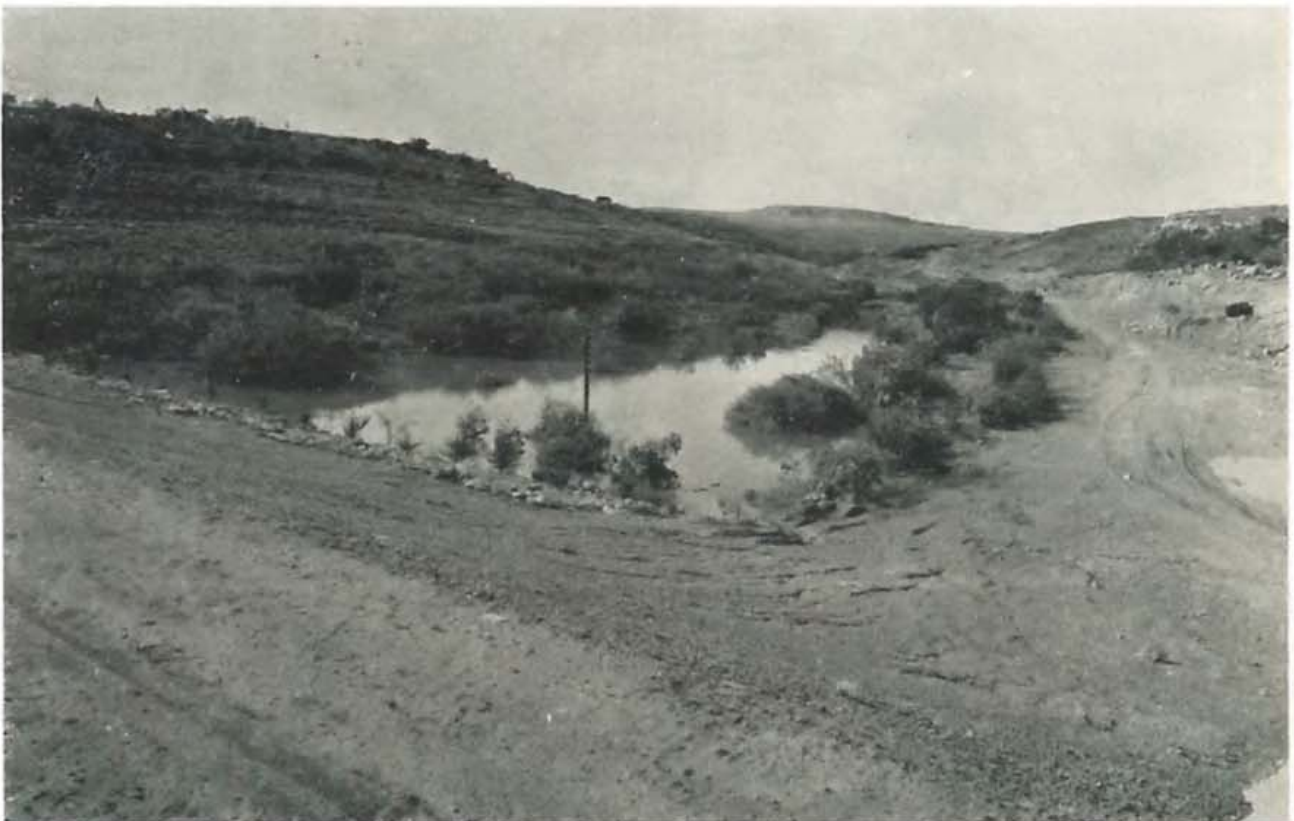
*The Panayia recharge dam at Paralimni.*

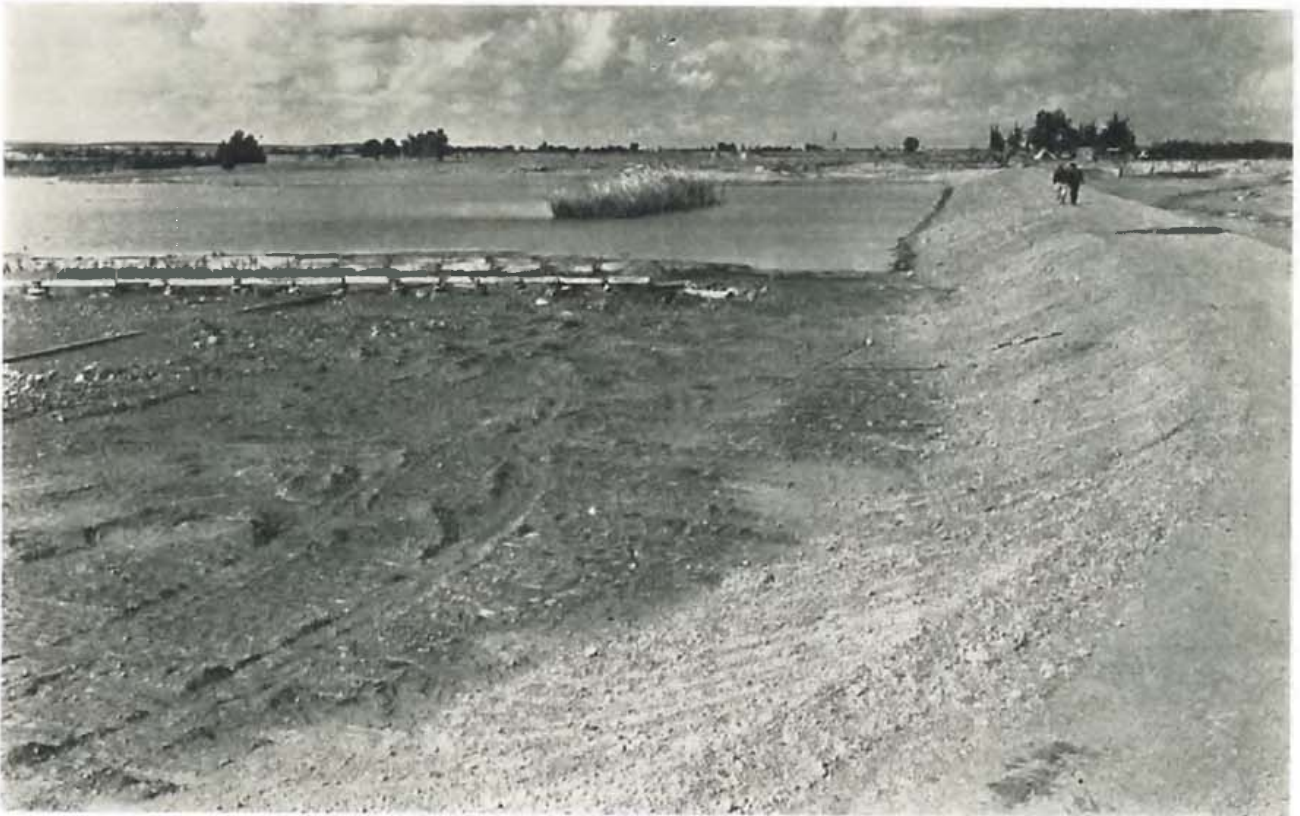
*Recharge dam at Makrasyka.*

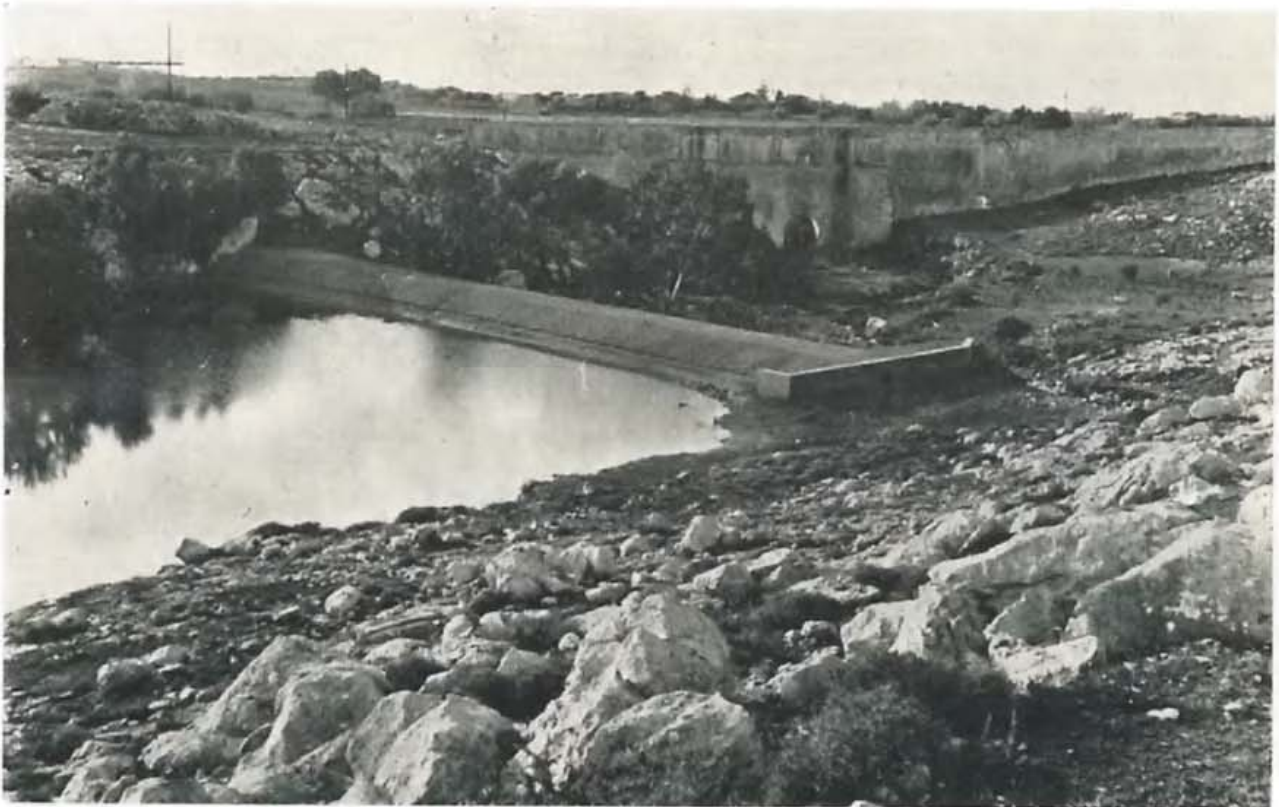
*Ayia Napa typical recharge dam. An old aqueduct can be seen in the background.*

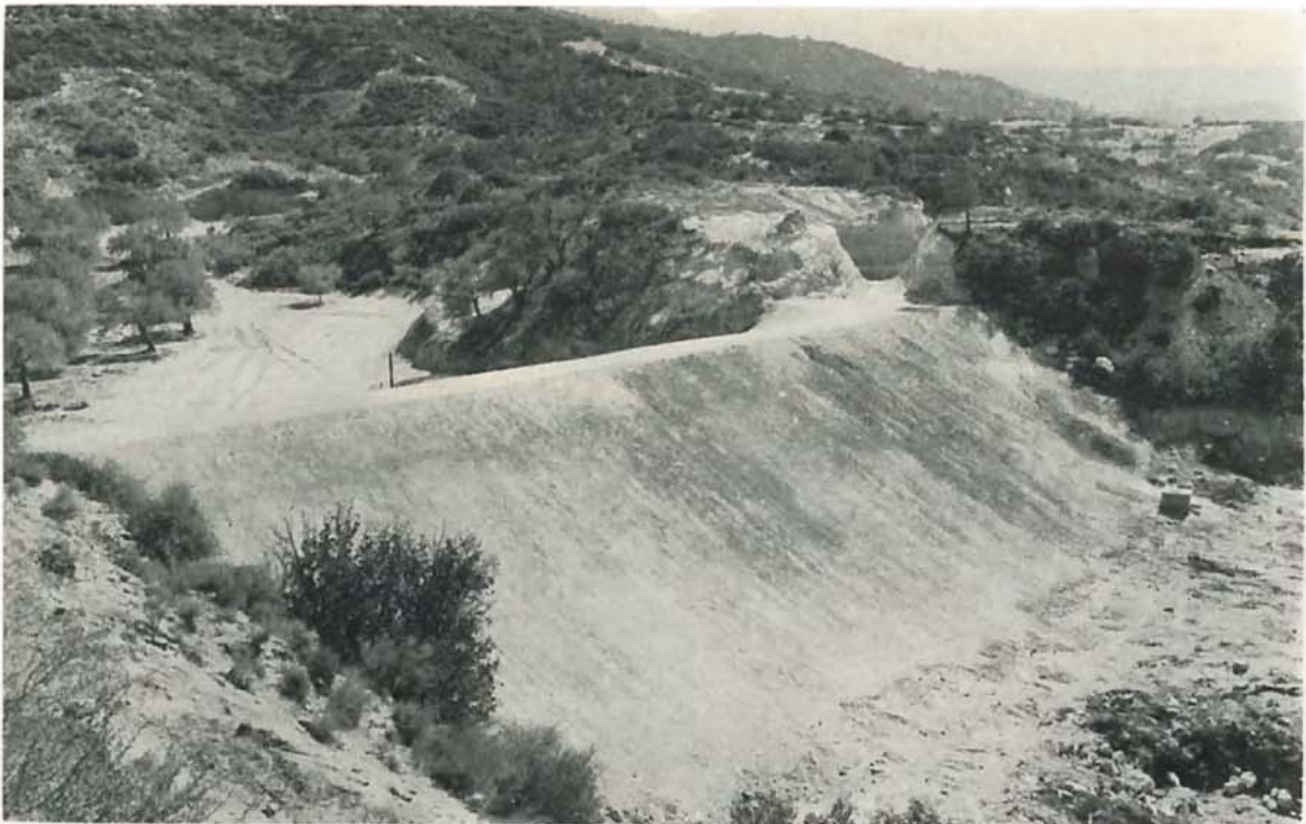
*Akanthou typical recharge dam.*

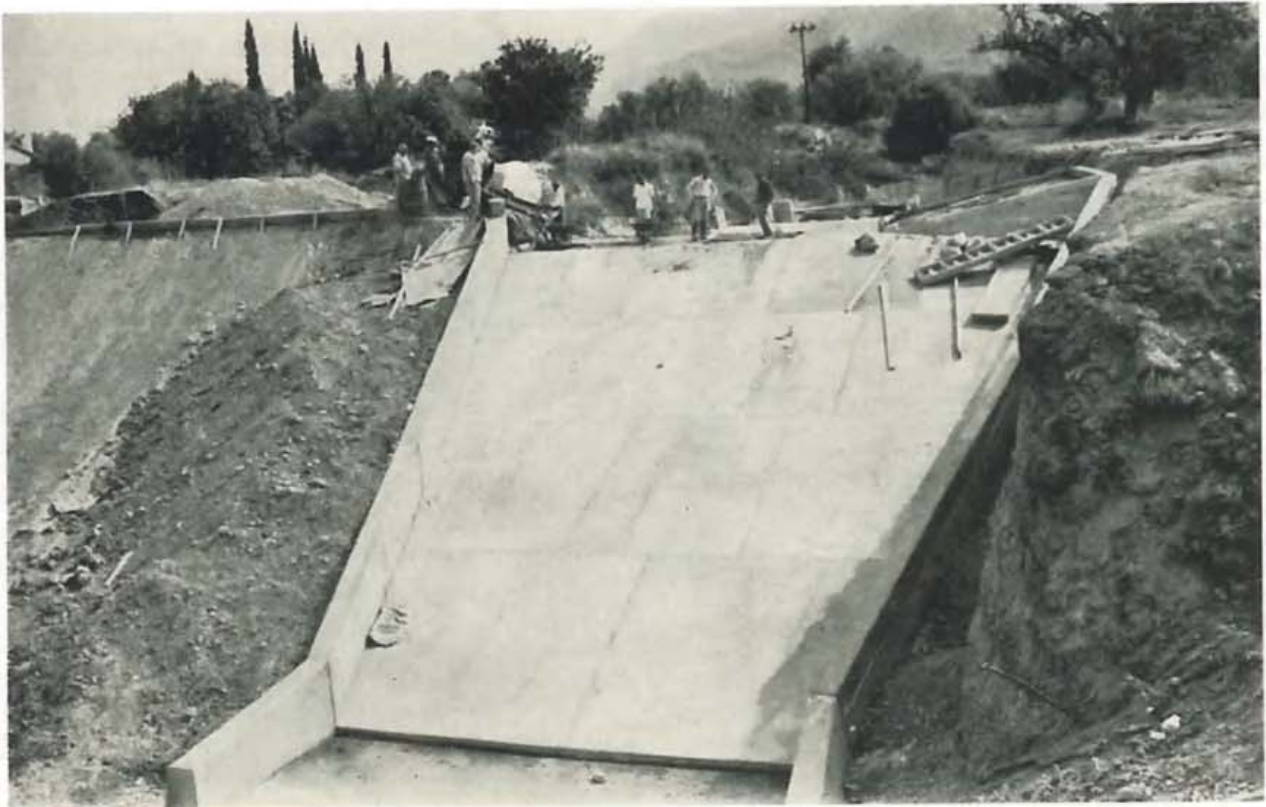
*Recharge dam at Karakoumi.*
